Marulan South Limestone Mine Continued Operations Project

Boral Cement Limited

**Annual Environmental Management Review
1 July 2023 to 30 June 2024**

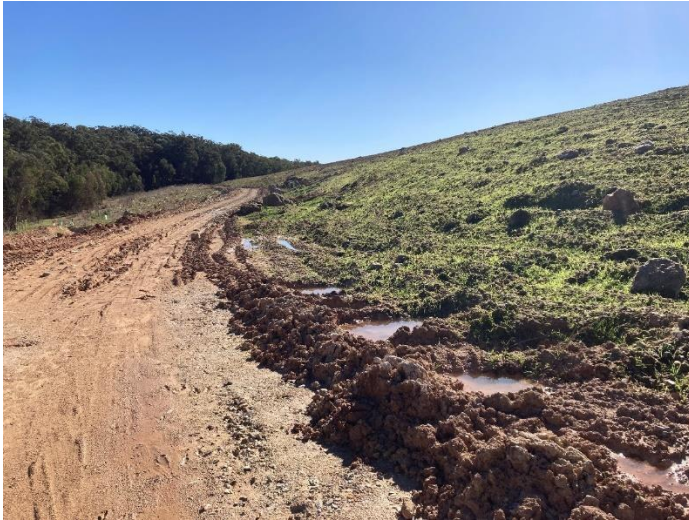
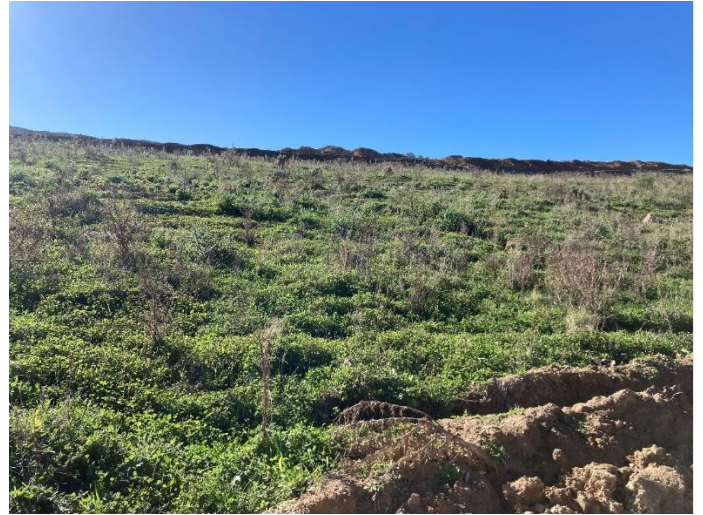
Plate 3 Western Overburden Emplacement Rehabilitation

During the reporting period, overburden continued to be emplaced in the WOE and the final batter height was reached. Topsoil rich in seed was relocated from recently cleared areas on site. This topsoil was spread across 2.5 hectares on the uppermost bench and 6.6 hectares of the previously rehabilitated lower benches. To take advantage of the topsoil made available through clearing activities on site, spreading was selected in preference to hydro mulching. This was also recommended by the hydro mulching contractor regarding the suitability of forecasted weather conditions in the Spring. Final landform establishment was achieved on some area of the WOE during the period.

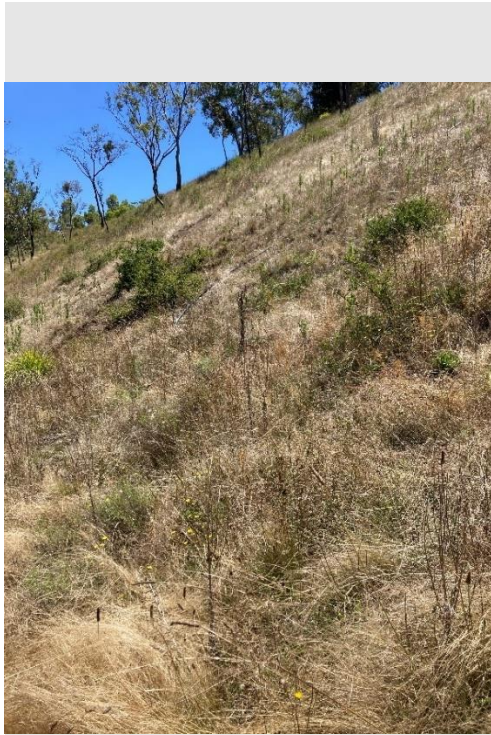
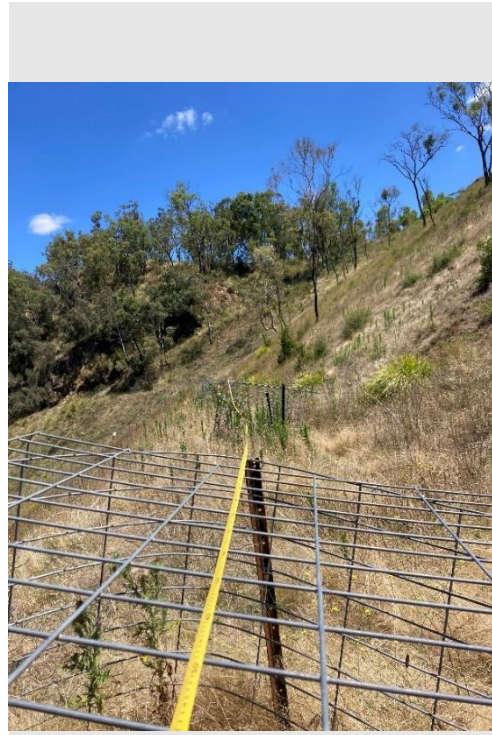
Plate 4 Bryces Gully bench 2 (EFA site 4)

The site specific Bryce's Gully Rehabilitation Strategy was implemented in 2019. The general objectives for rehabilitation of the gully are to construct a geotechnically stable landform which does not present a greater safety hazard than the surrounding land; create land to be visually compatible with the surrounding natural landscape and to not negatively impact the visual amenity of the gully. The rehabilitation progression is monitored annually using EFA (See Section 8.4).

A Geotechnical report on Bryce's Gully was completed during 2023 which deemed the slope unstable at this time (See Section 6.11). It was advised that personnel should avoid entering this area as it may not be safe. Rehabilitation works planned for the upcoming reporting period have been put on hold until actions can be put forth to ensure slope stability.
