Kooragang Island resource recovery facility

Surface water discharge characterisation assessment

Prepared for Boral Recycling Pty Limited
November 2019

H180253 RP1

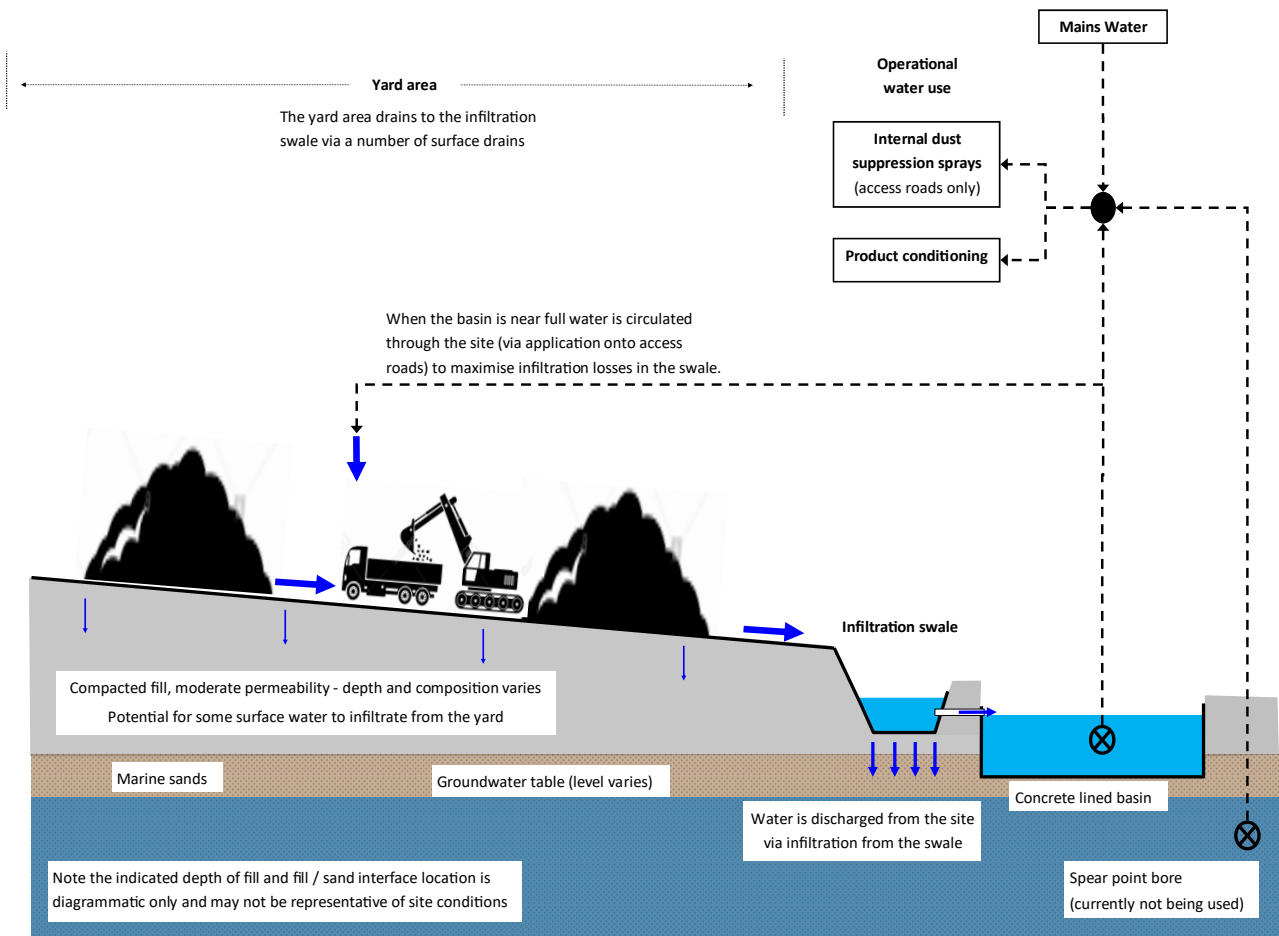
The facility's water management system manages stormwater runoff and provides water for operational uses such as dust suppression and product conditioning. The system's key functionality is described as follows:

- The yard has been established on compacted fill that is assessed to have moderate permeability when saturated and sits above a shallow unconfined groundwater system.
- Surface water runoff from the yard drains through several discrete surface drains to an infiltration swale located along the northern boundary. Water in the swale slowly infiltrates into the underlying groundwater system.
- The swale overflows into a concrete-lined basin.
- Water captured in the concrete-lined basin is used for operational uses such as access roads dust suppression and product conditioning. During dry periods, additional water is sourced from the underlying groundwater system (via a spearpoint well located near the basin) or from the mains potable water supply. Boral were not using the spearpoint well during the SWDCA period (June 2018 to August 2019).

Figure ES1 Conceptual framework of the water management system

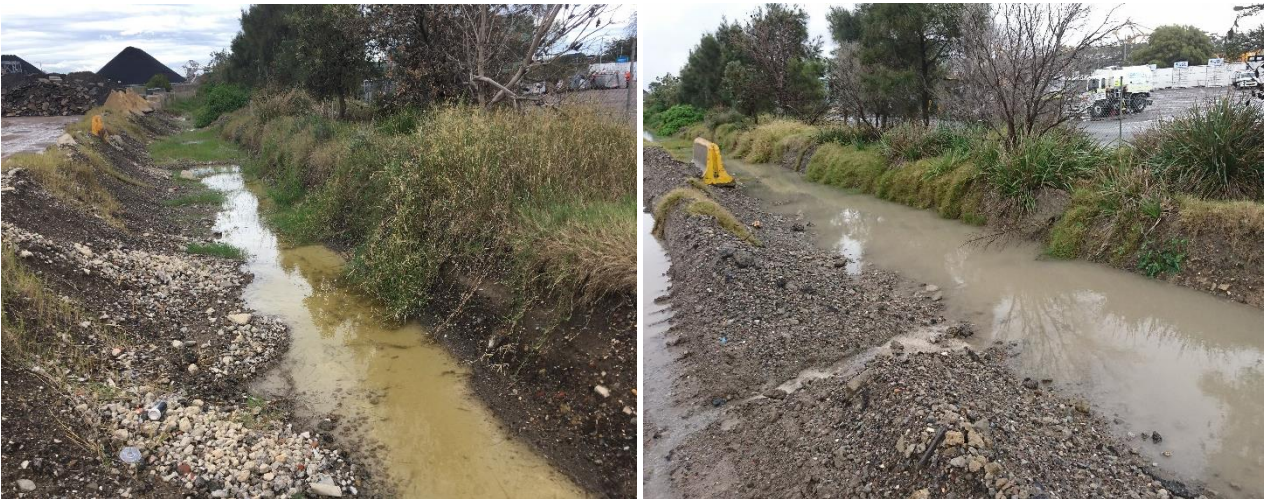
Photograph 2.1 Infiltration swale - the image on the left was taken in March 2019, after 50 to 60 mm of rainfall. Only minor amounts of surface water runoff occurred from this event. The image on the right was taken in August 2019 after approximately 80 mm of rain. Significant surface runoff from the yard occurred from this event.

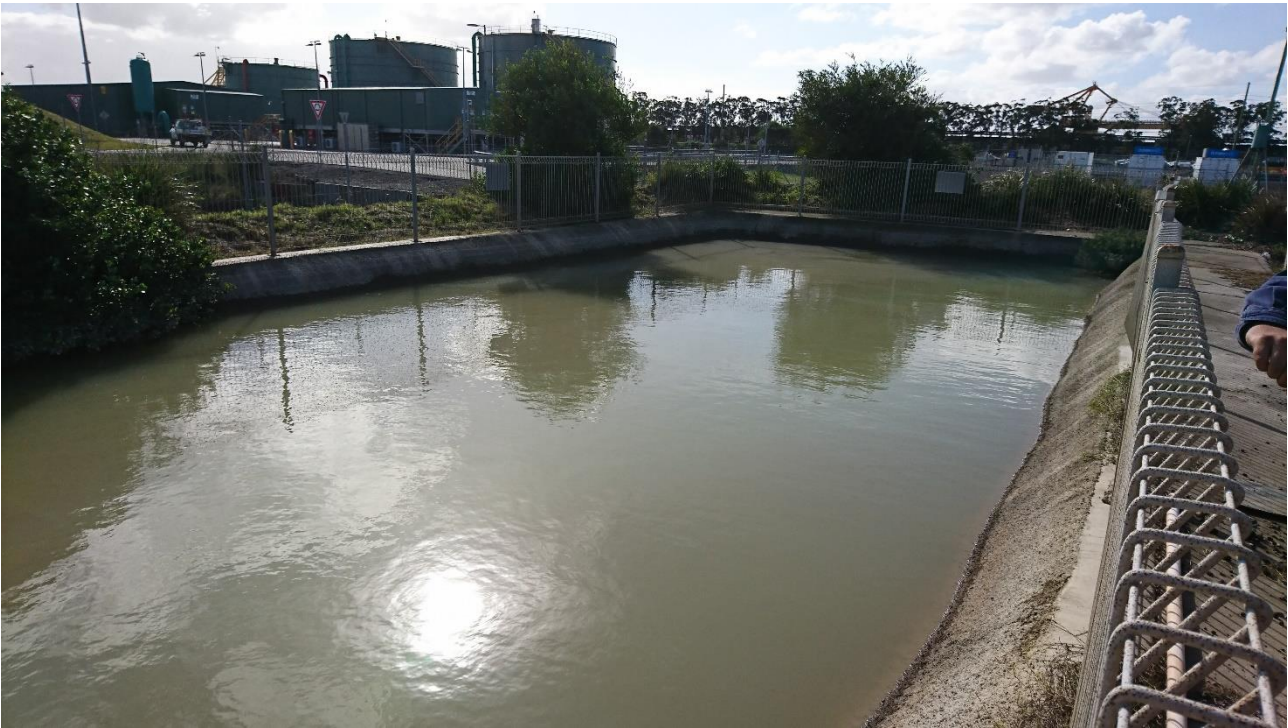
The swale overflows into a concrete-lined basin (see Photograph 2.2). Water captured in the basin is used for operational uses such as access roads dust suppression and product conditioning. During dry periods, additional water is sourced from the underlying groundwater system (via a spearpoint well located near the basin) or from the mains potable water supply. Boral were not using the spearpoint well during the SWDCA period.

Photograph 2.2 **Concrete-lined basin**

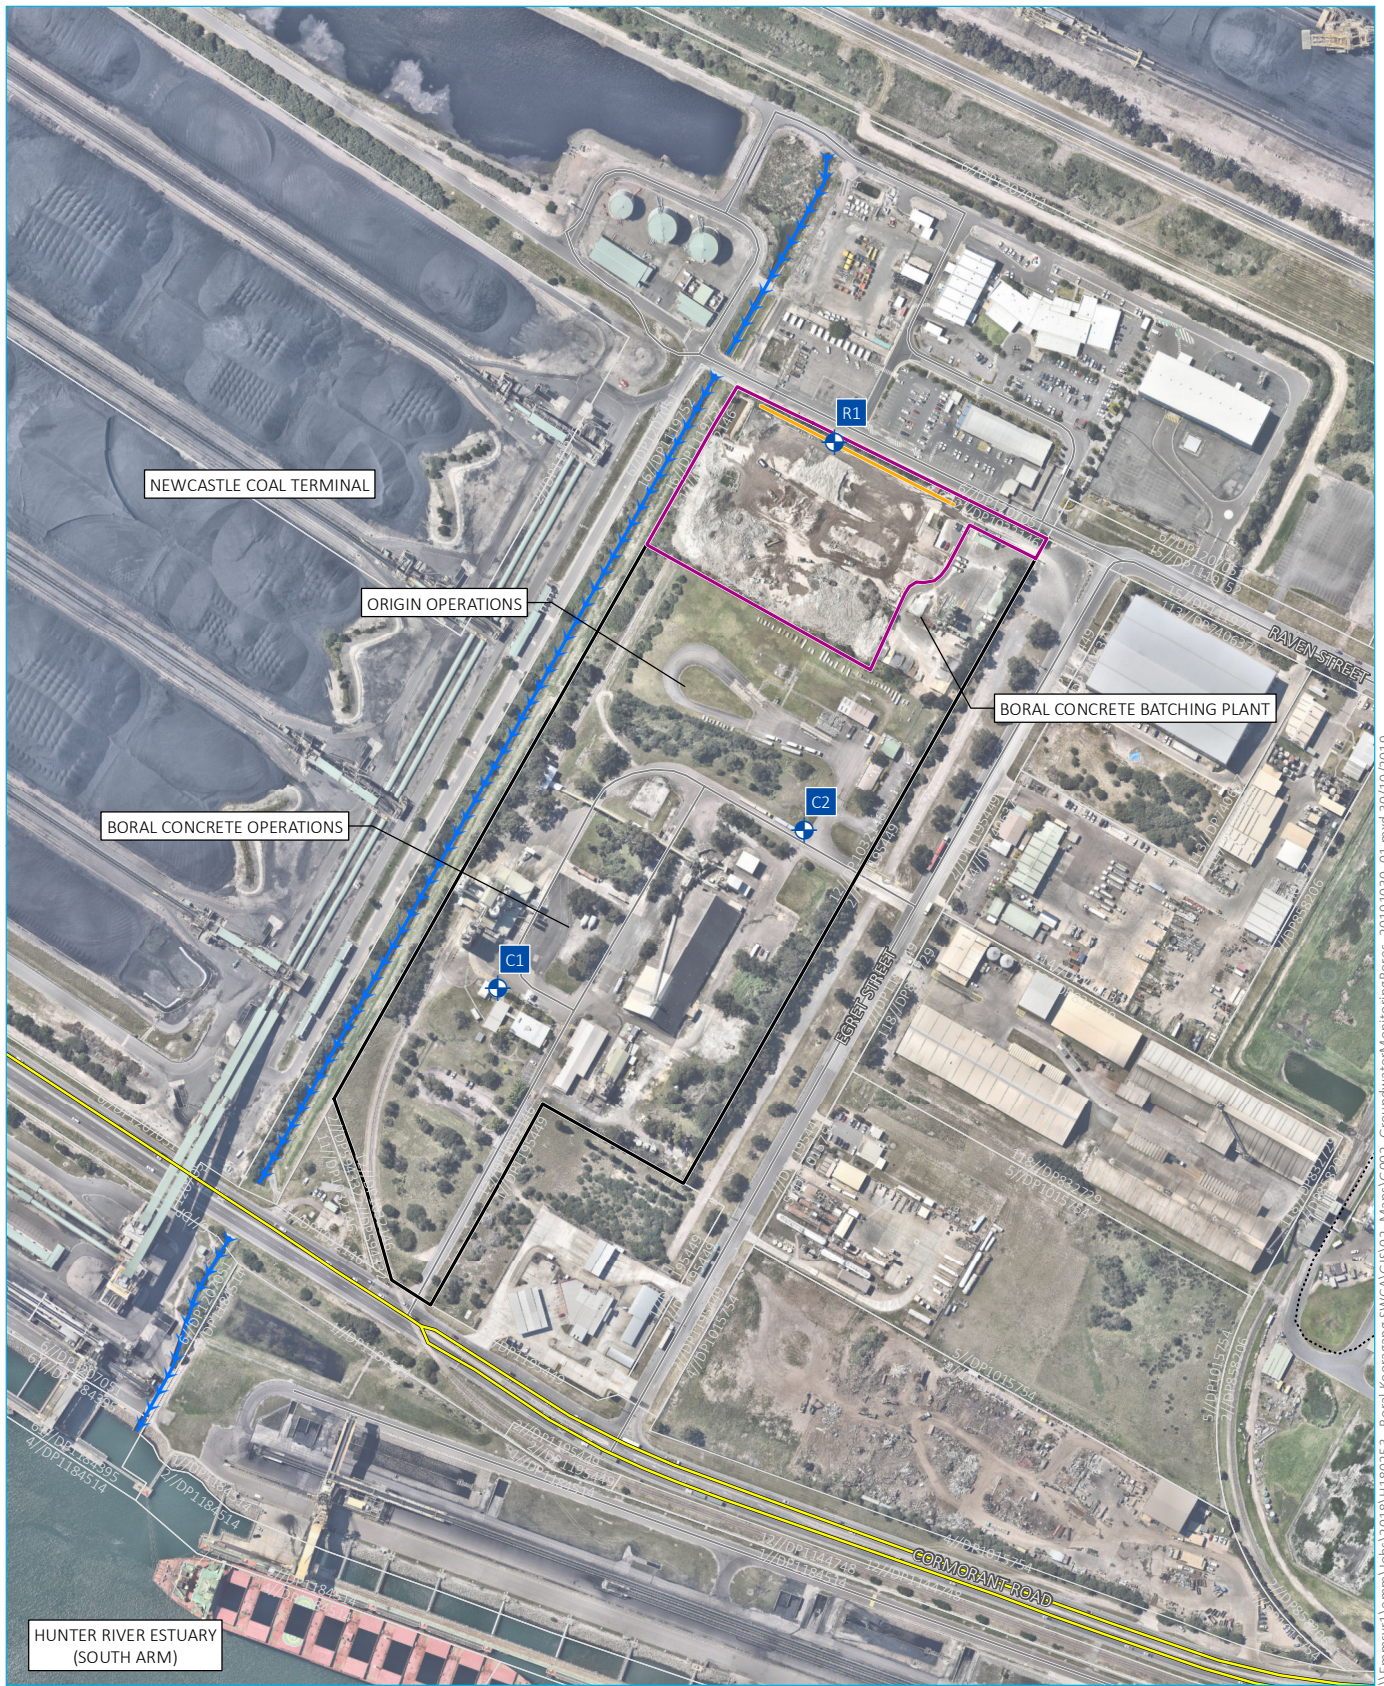
- Two water-bearing zones, separated by a low permeability unit of clay, were encountered when drilling monitoring bore C1 adjacent to the offices of Boral Cement Works (the bore location is shown in Figure 3.1). An unconfined shallow perched aquifer was observed within an upper sand unit (2.6 to 2.8 m below ground level) and a deeper confined aquifer within a lower sand unit (4.5 to 4.5 m below ground level). Both zones are interpreted to have high permeability due to the sand media.

- Groundwater monitoring was undertaken by SLR in 2015 (SLR 2015) from monitoring bores R1 and C1 (the bore locations are shown in Figure 3.1). The monitoring identified non-trivial concentrations of PAH and TRHs. These were interpreted to be associated with the former use of spoil and slag as fill. All analysed metal concentrations were below ANZECC/ARMCANZ (2000) Default Guideline Values (DGVs) for 95% species protection (freshwater) except for zinc.

- Regional groundwater flow is interpreted to be in a southerly direction towards the southern arm of the Hunter River Estuary, which is located 700 m from the facility. However, some groundwater from the facility area may also flow into the existing drain that is located immediately to the west of the facility. This drain also flows in a southerly direction and enters the southern arm of Hunter River Estuary near the coal loading facilities (see Figure 3.1).

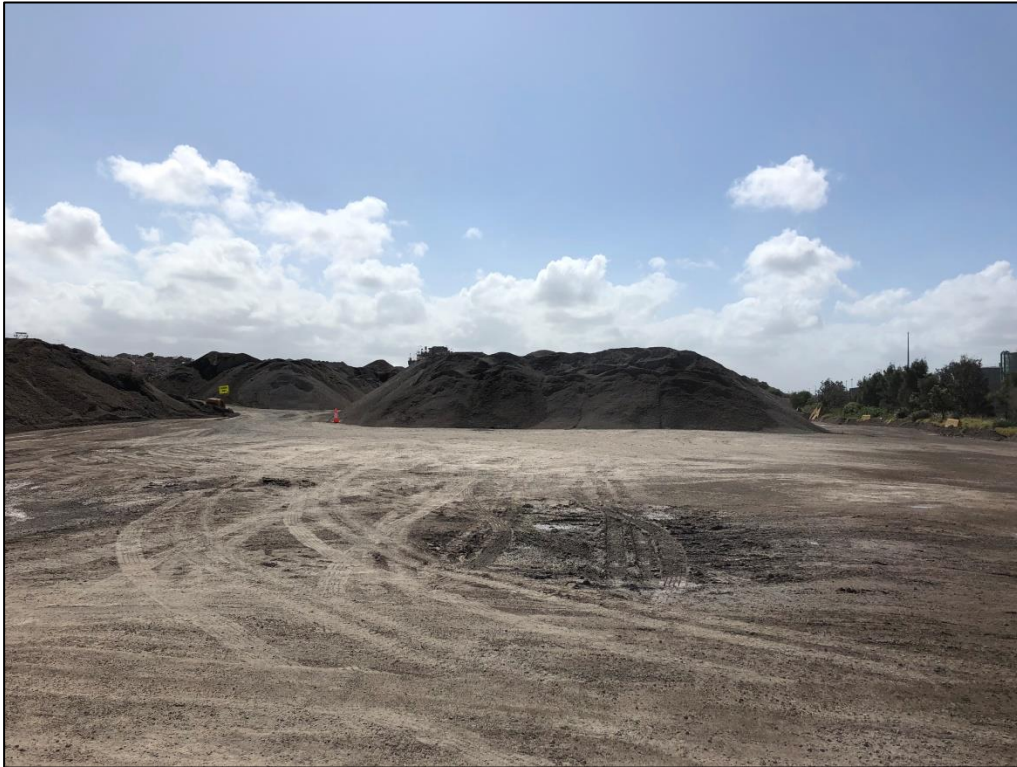
Figure 1: Looking north-west from near test Location 6.

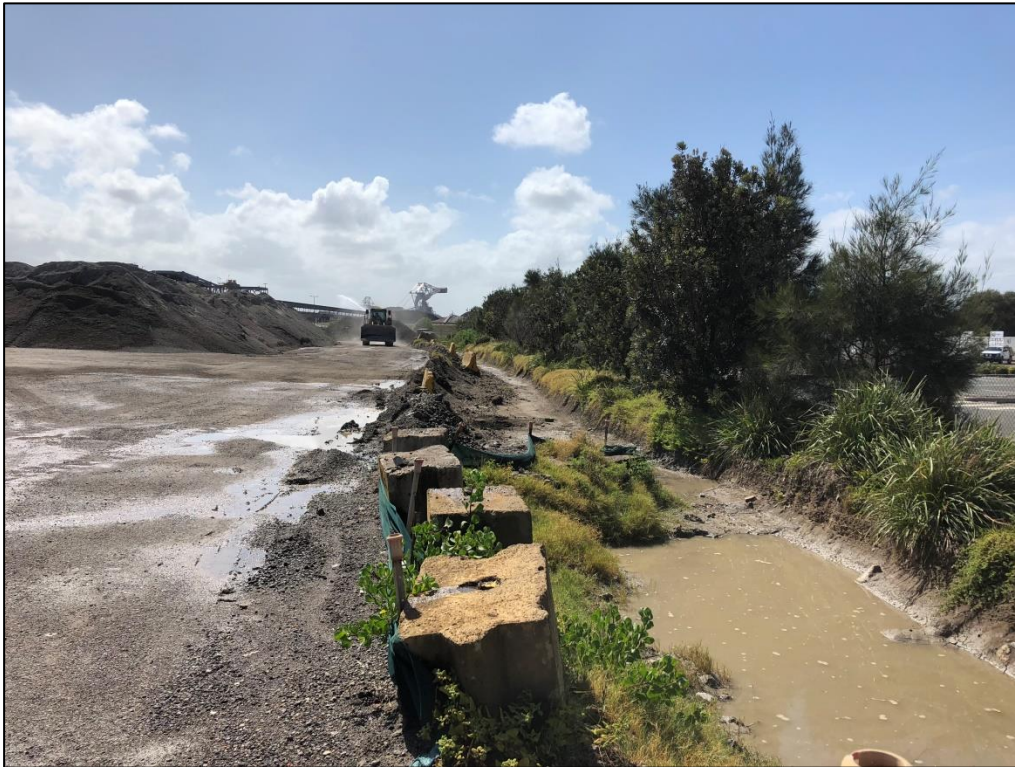
Figure 2: Looking north-west along drainage swale from near the weighbridge.

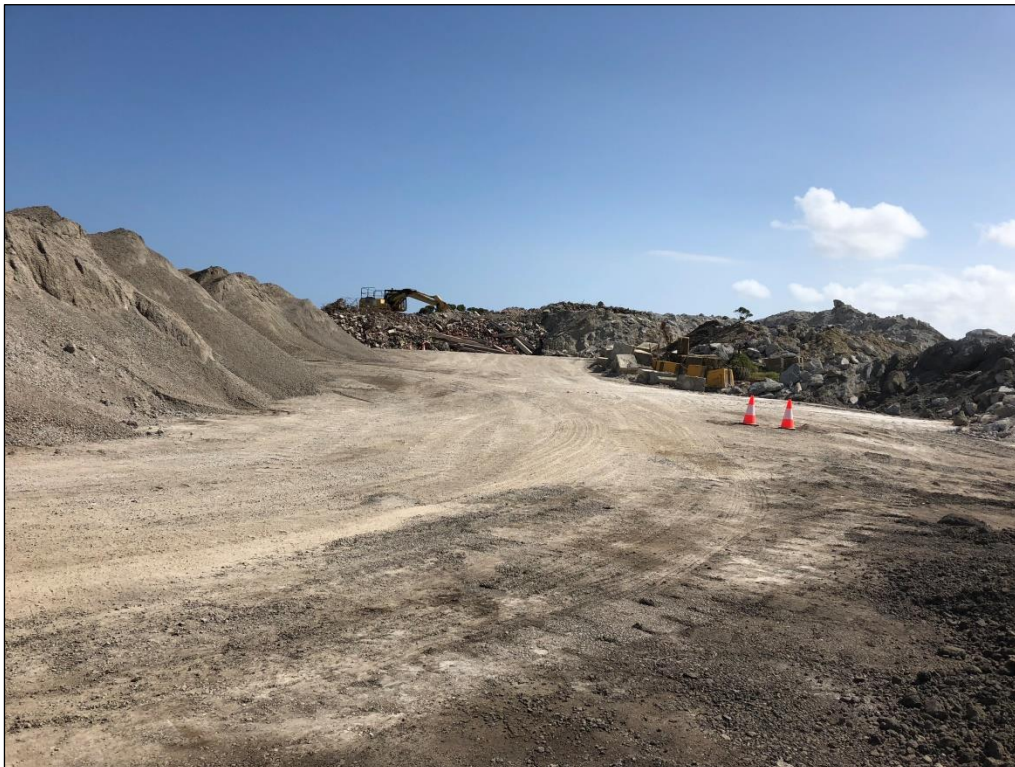
Figure 3: Looking south-west from near Test Location 9, towards Test Location 4 (orange cones)
