Dunmore Hard Rock Quarry Annual Review

1 July 2020 – 30 June 2021

Dunmore Hard Rock Quarry Annual Review Title Block

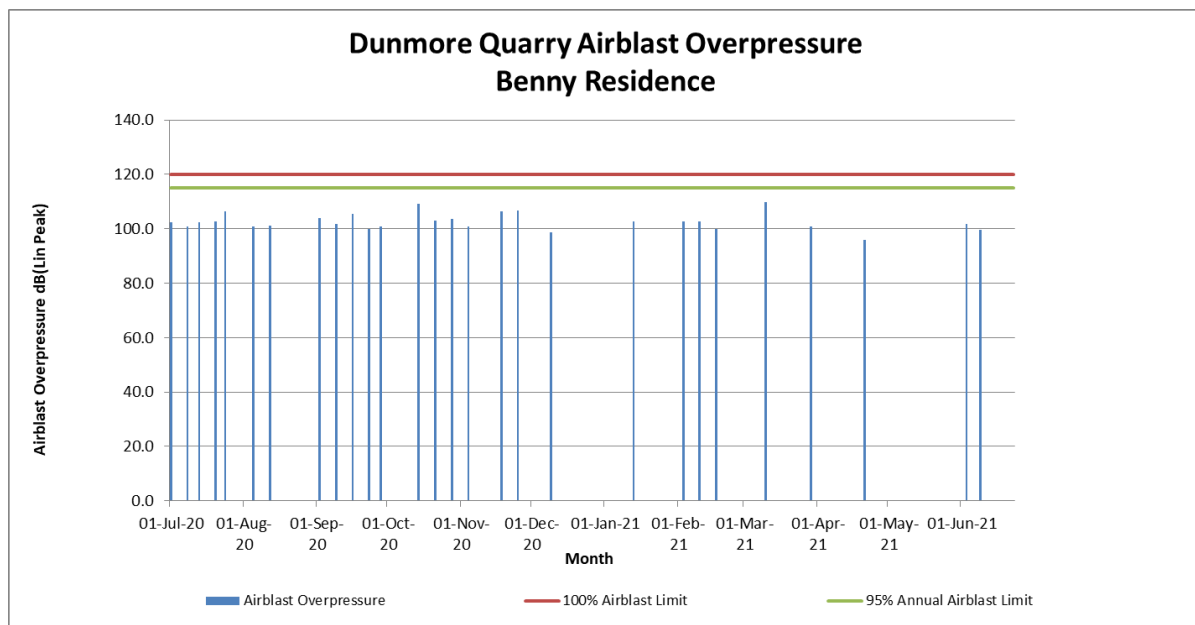
Figure 11 FY21 Overpressure Data

Figure 11 and Figure 12 details a visual representation of the blast monitoring in FY21.

There were no blasts above the prescribed limits during the FY21 reporting period.

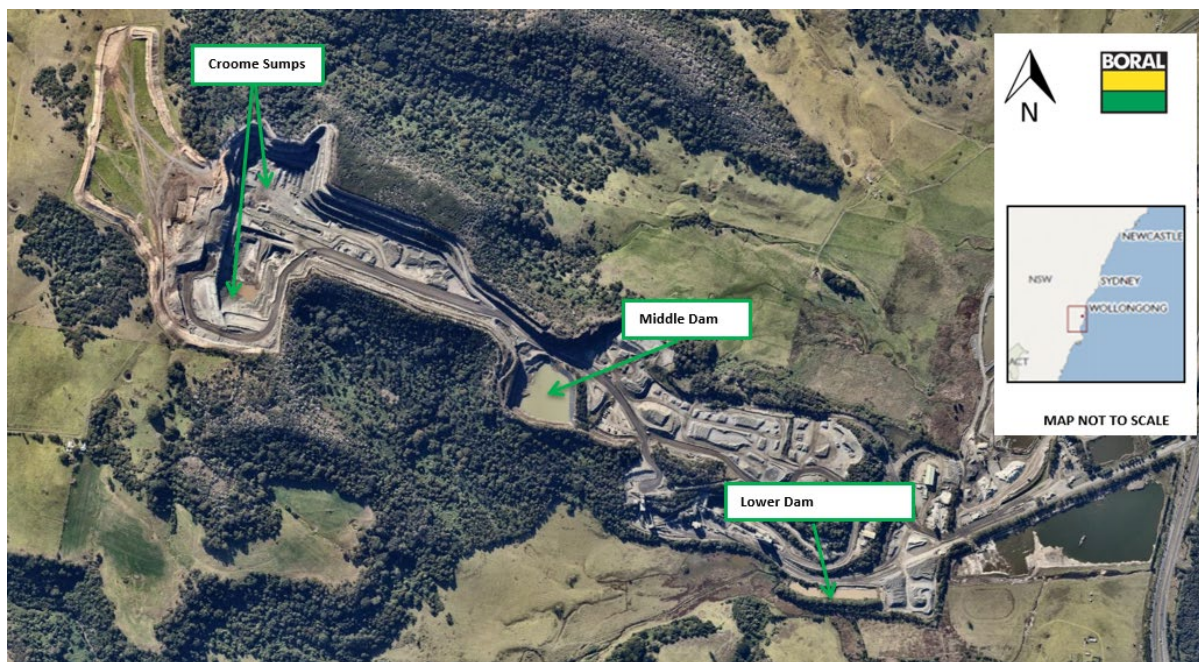
Figure 27 Water Storage Locations

All process water was sourced by either the Lower Dam, Middle Dam or Croome Sumps, which are offline from Rocklow Creek as per water management upgrades undertaken in 2008 under MOD 4. The Location of water storage infrastructure is shown below in Figure 27.

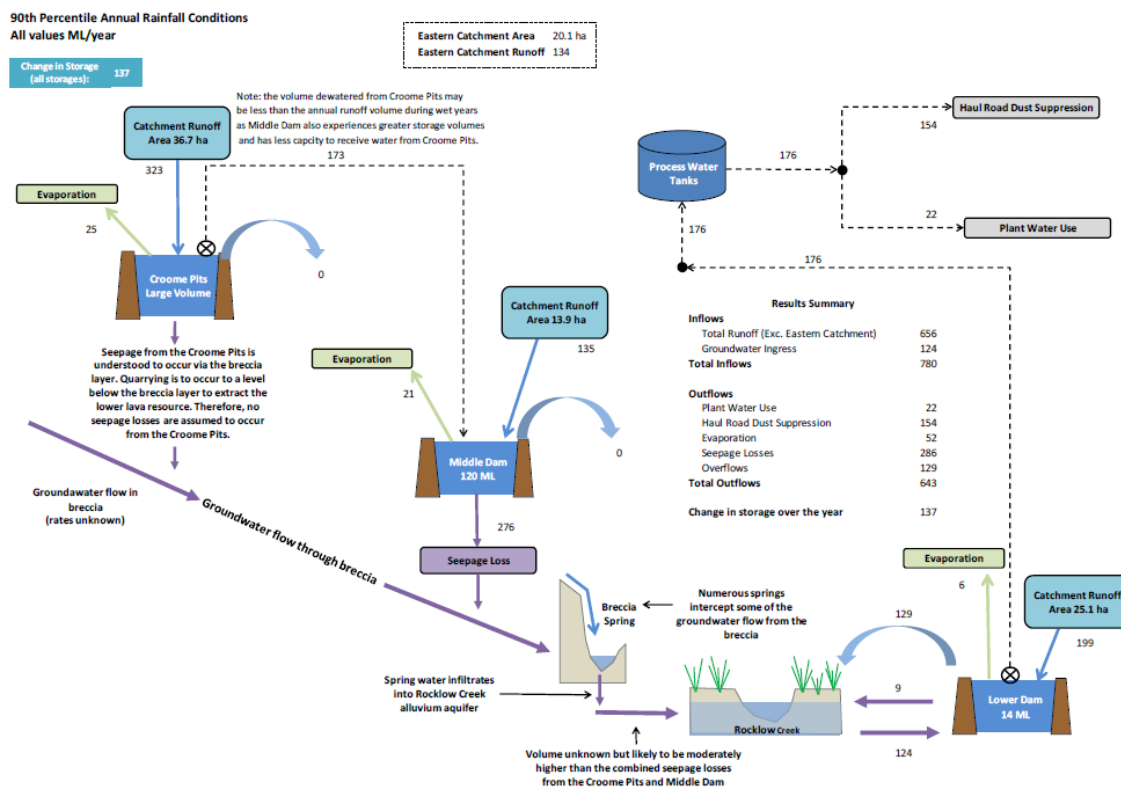
Figure 28 Existing water management system: typical wet year water balance

The updated WMP outlines a range of water balance scenarios based on different climate conditions. The wet year scenarios (90th percentile 1,658mm rainfall) best reflects rainfall for the FY21 period (annual rainfall was 1,556mm) as shown in Figure 28. As a result, the process water use was modelled to be 176ML for the reporting period with a change of storage of +137ML over the year within the three dam storages.

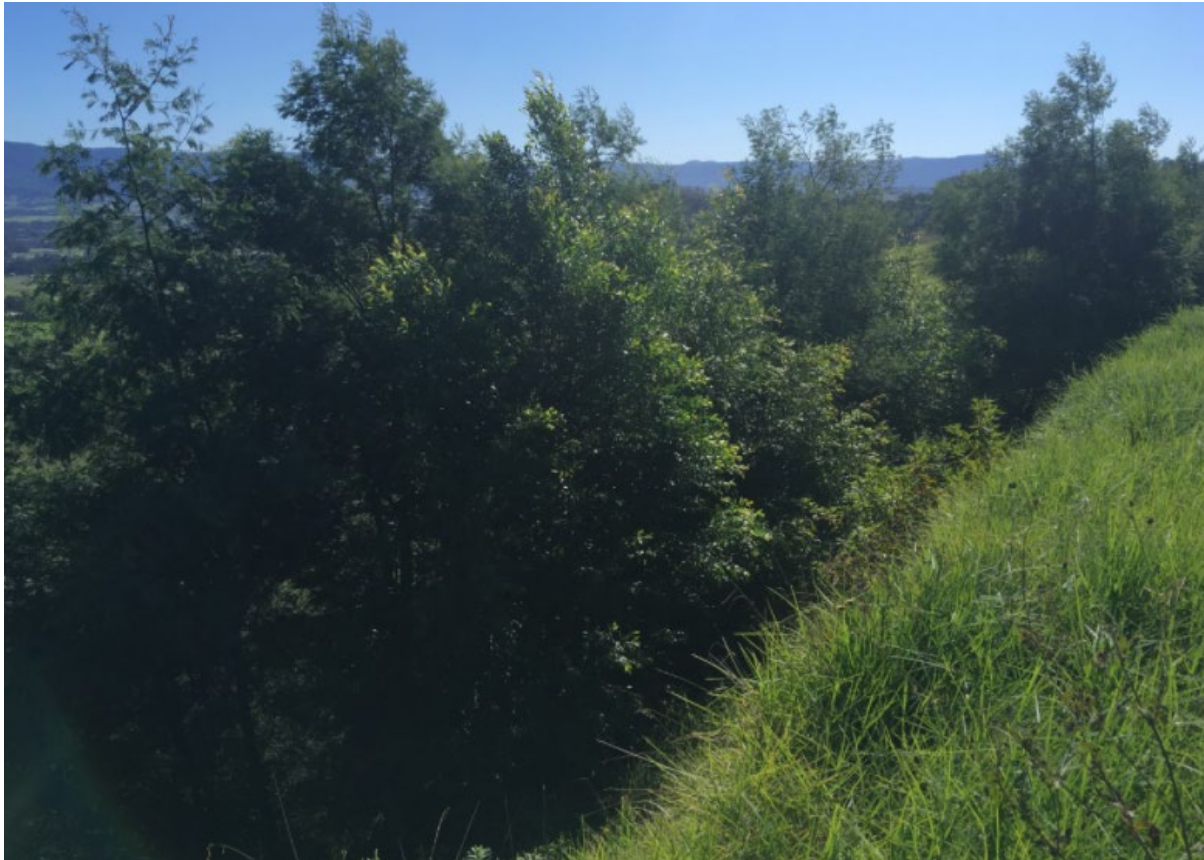
Figure 30 Hydroseeding cover and trees over Croome West Bund

Most areas of the site are currently operational and as such rehabilitation is not able to commence on the majority of areas within the quarry until the completion of extraction activities. When practical, progressive rehabilitation of the site will be undertaken in conjunction with on-going quarrying works. Hydroseeding of the Croome West Bund is now well established with trees as shown below in Figure 30.

In the last 12 months, rehabilitation within the quarry itself has continued on the Croome West amenity bund. Hydro-seeding took place in the northern section of the bund in 2018 and 2019 with more infill seeding to occur during the next reporting period.

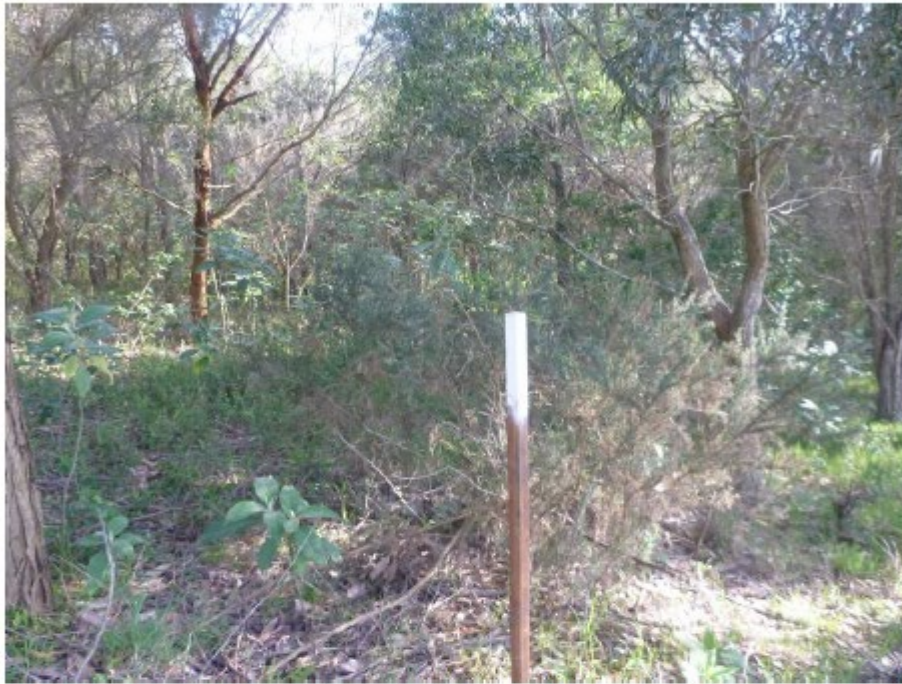
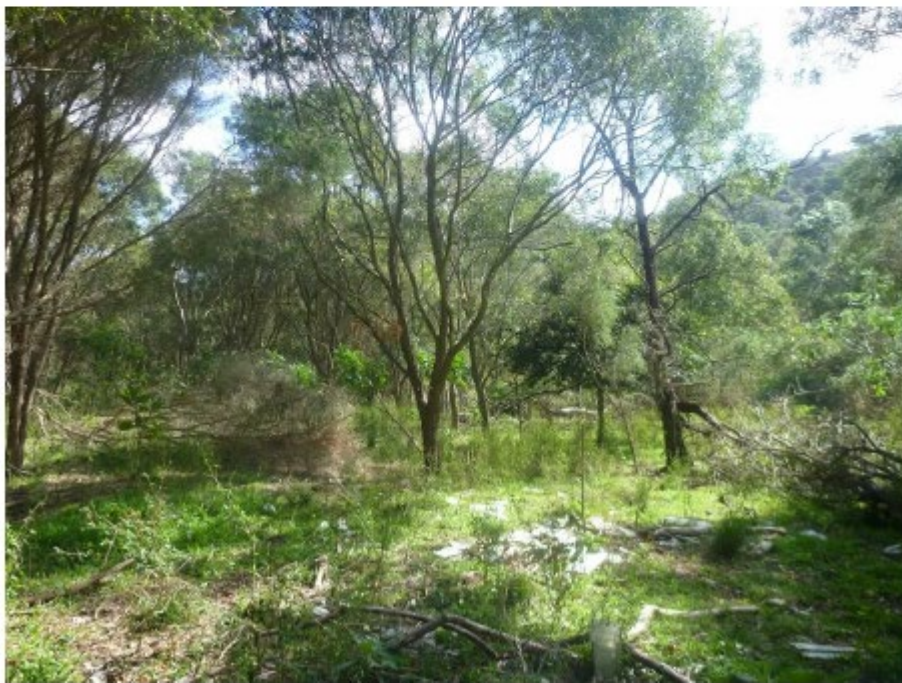
Figure 32 Photomontage of vegetation condition at RVCA1

RVCA1 Photo point prior to primary weed control November 2019 (photo point marker was removed)

Similar area after primary weed control, September 2020

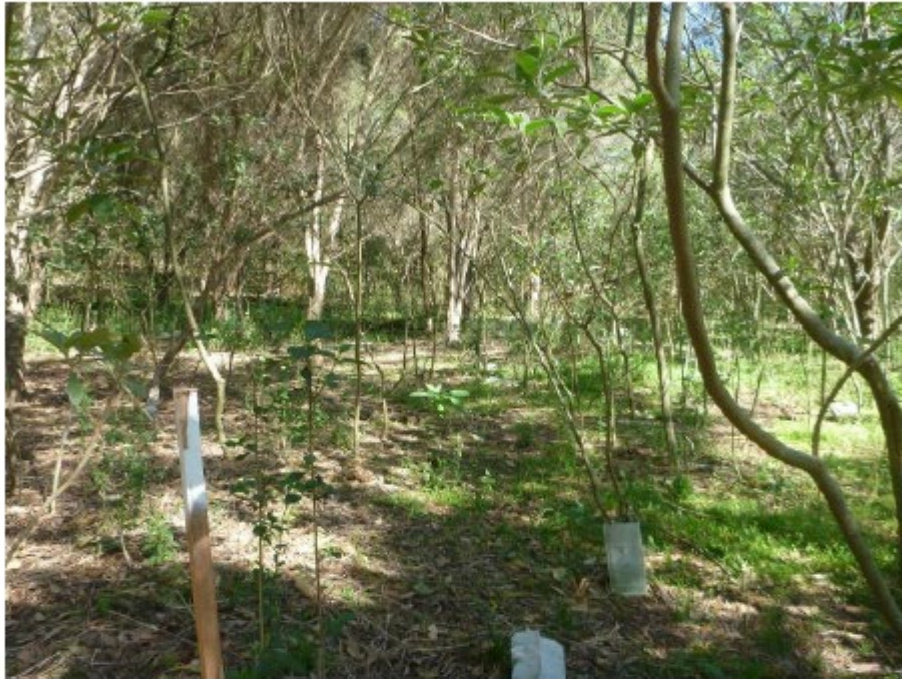
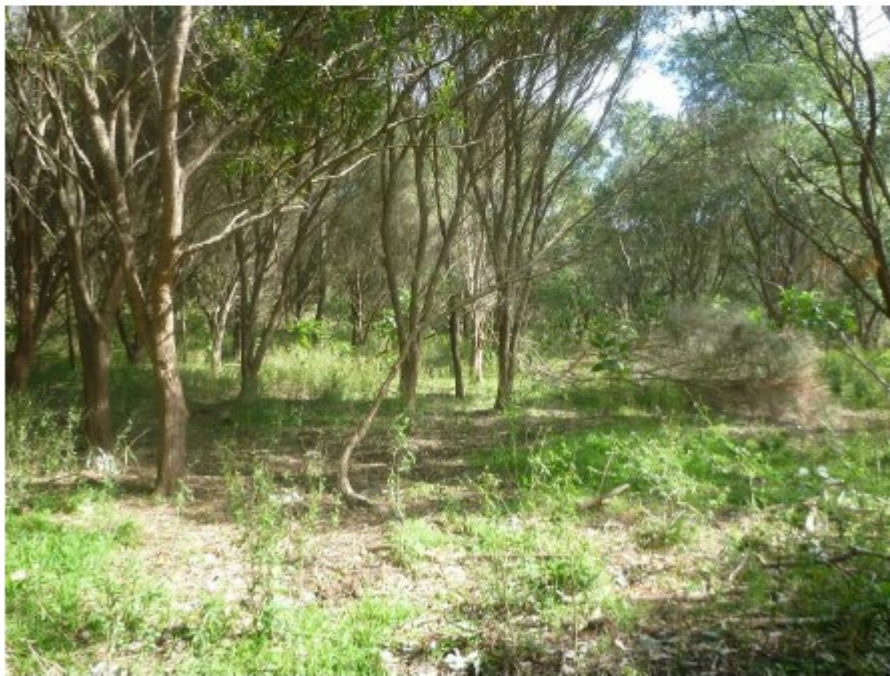
Figure 33 Photomontage of vegetation condition at RVCA2

Photo Point	RVCA2		
Commencement of works date	September 2020		
Completion of works date	August 2021		
Vegetation Condition		Percentage Cover prior to works	Percentage Cover post works
Upper Stratum (emergent canopy)	The upper stratum surrounding this photo point is dominated by a tall canopy of <i>Melaleuca armillaris</i> <i>Acacia maidenii</i>	100% native cover	100% native cover
Mid Stratum (sub canopy)	The mid stratum surrounding this photo point is dominated by <i>Solanum mauritianum</i> *	20% native cover 80% weed cover	0% native cover 0% weed cover
Shrub layer	The shrub layer surrounding this photo point is dominated by <i>Lantana camara</i> * <i>Ulex europaeas</i> *	0% native cover 100% weed cover	0% native cover 0% weed cover
Ground Layer	The ground layer surrounding this photo point is dominated by native and weed grasses as well as a range of annual weeds and woody weed seedlings such as <i>Lantana camara</i> * <i>Bidens pilosa</i> * <i>Pellaea falcata</i>	60% native cover 30% weed cover	70% native cover 30% weed cover

RVCA2 Photo point prior to primary weed control November 2019 (photo point marker was removed)

Similar area after primary weed control, September 2021

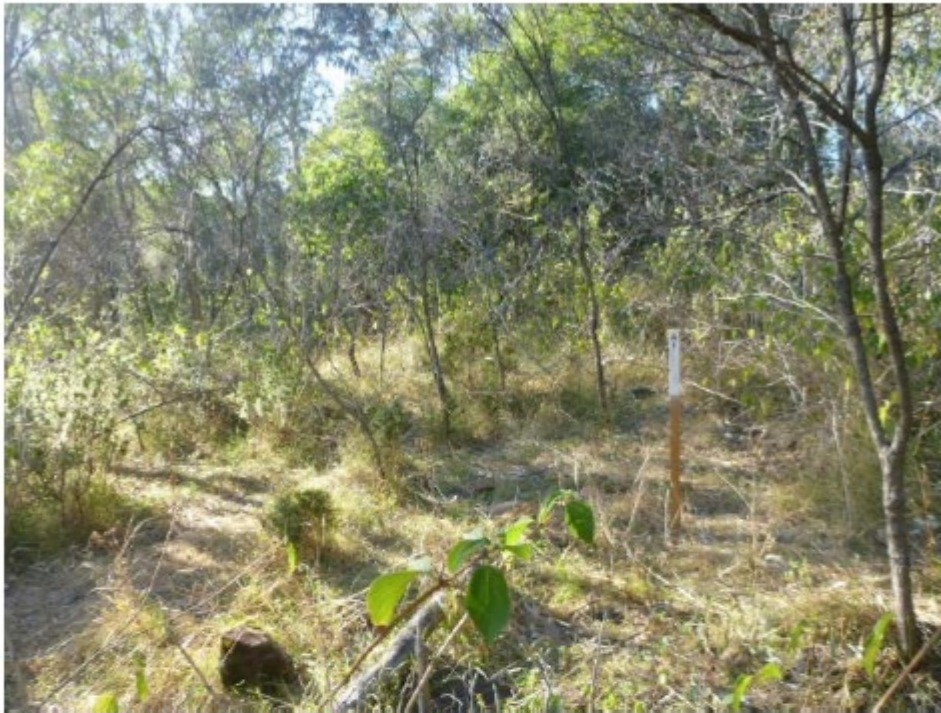
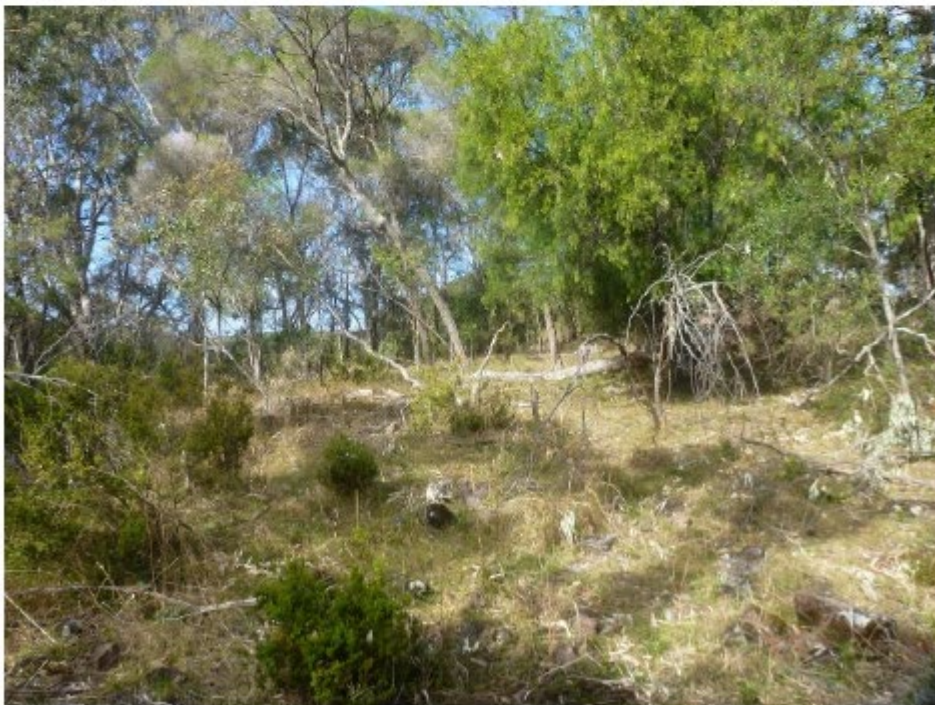
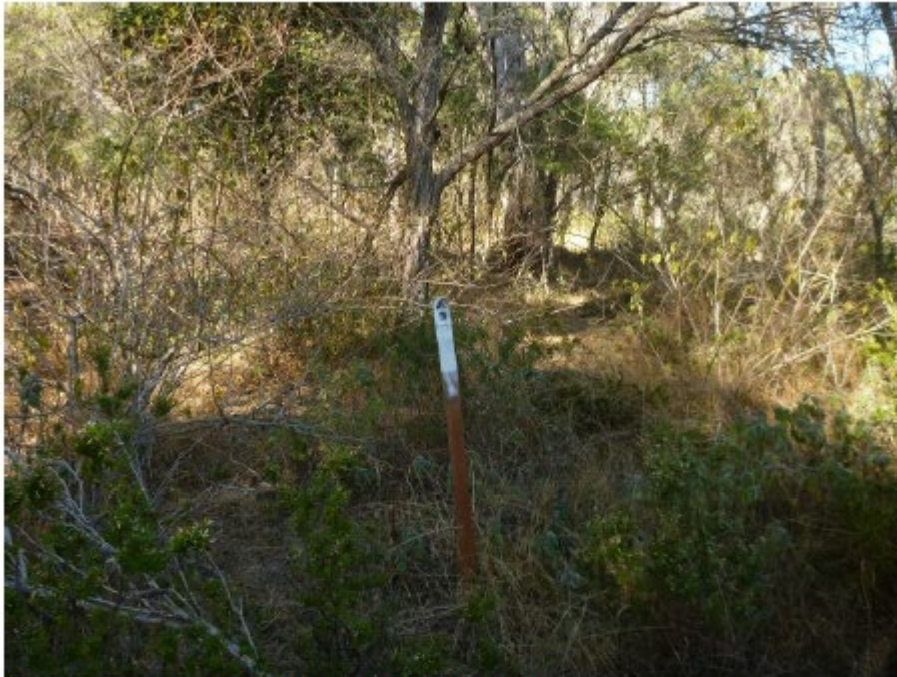
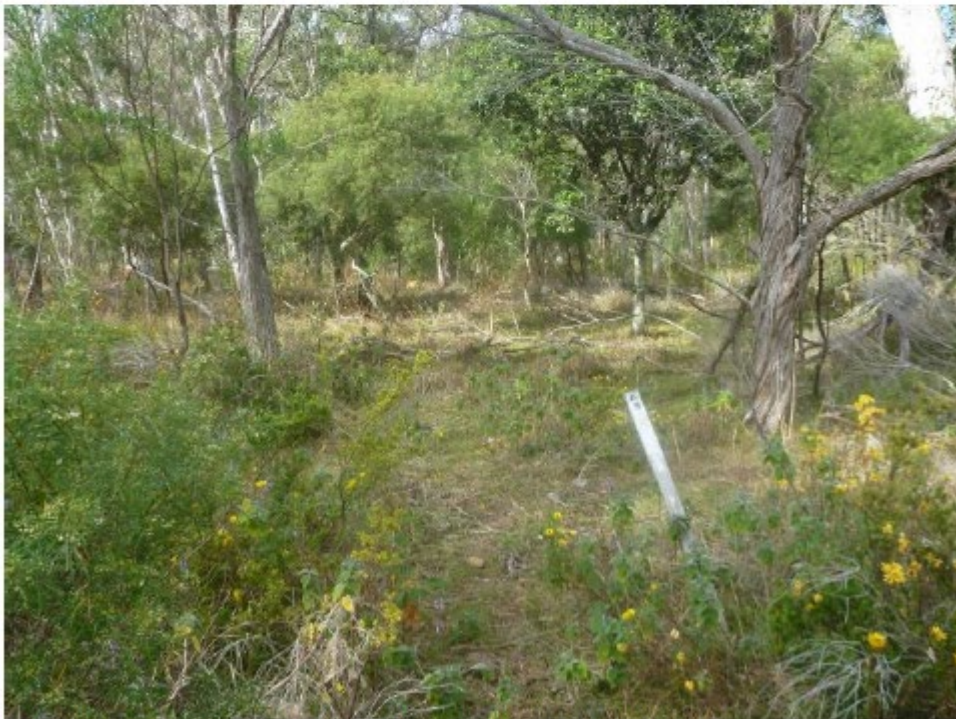
Figure 34 Photomontage of vegetation condition at Zone 2a

A1 Photo point prior to commencement of works in 2017

A1 Photo point after primary weed control and maintenance, September 2021

A3 Photo point prior to commencement of works in 2017

A3 Photo point after primary weed control and maintenance, September 2021

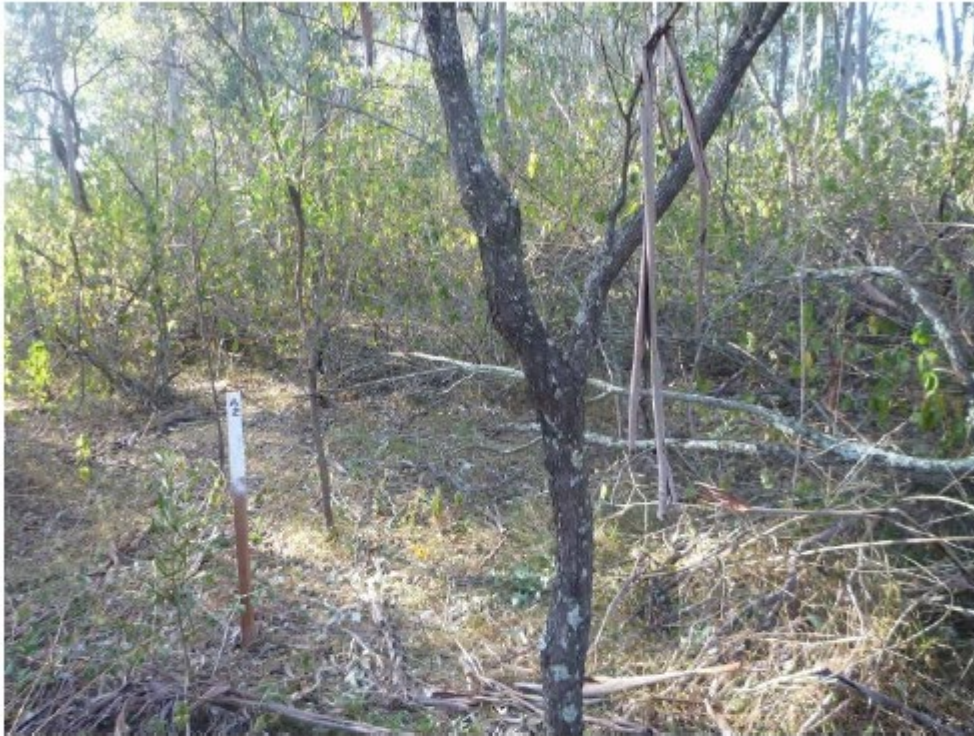
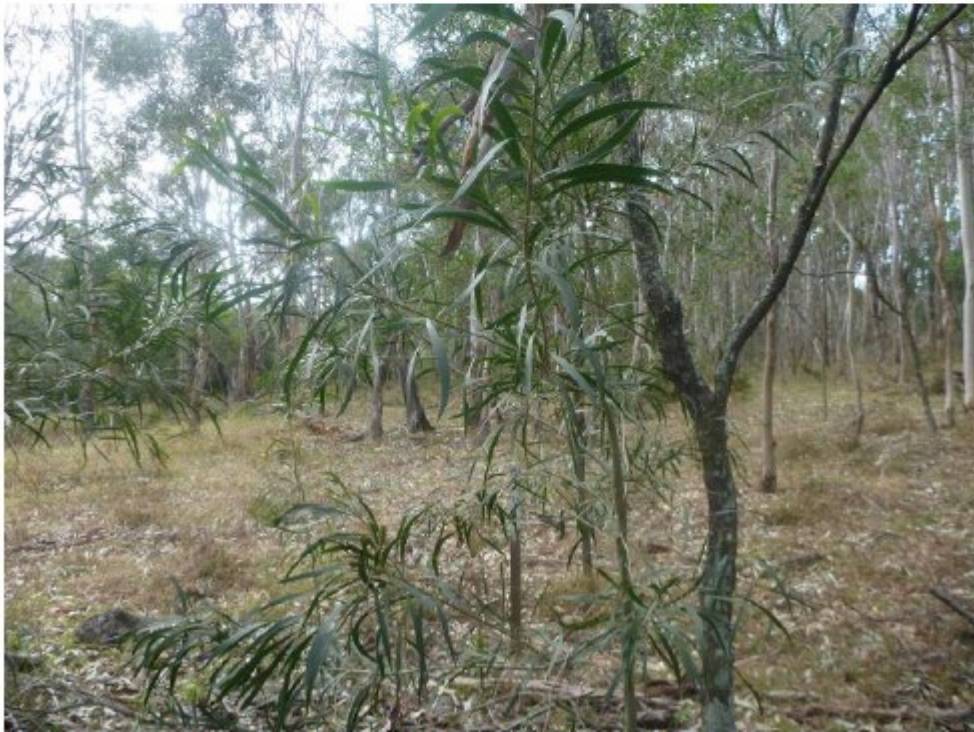
Figure 35 Photomontage of vegetation condition at Zone 2c

A2 Photo point prior to commencement of works in 2017

A2 Photo point after primary weed control and maintenance, September 2021

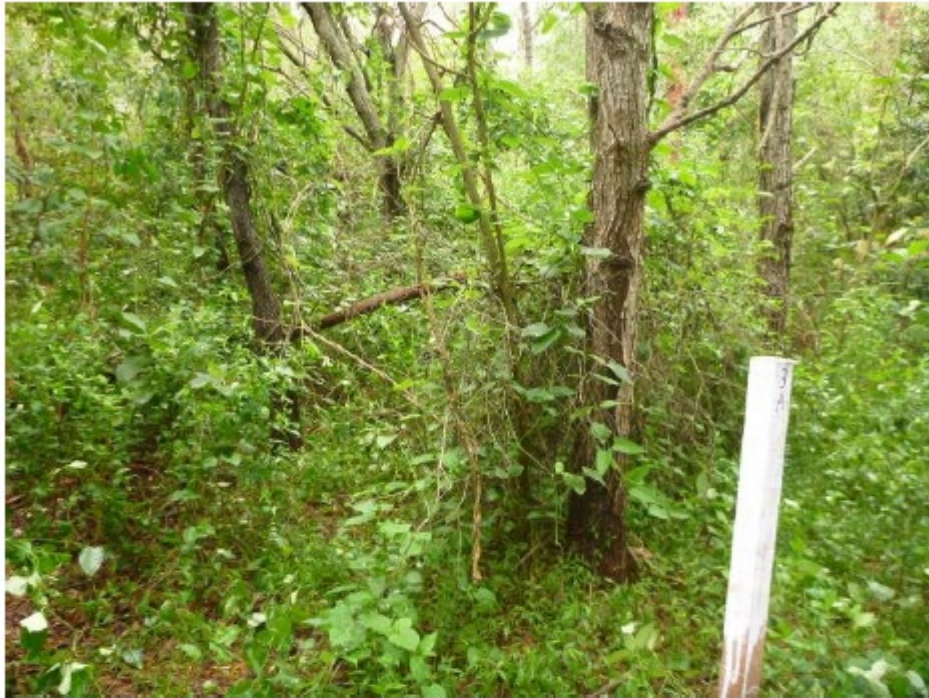
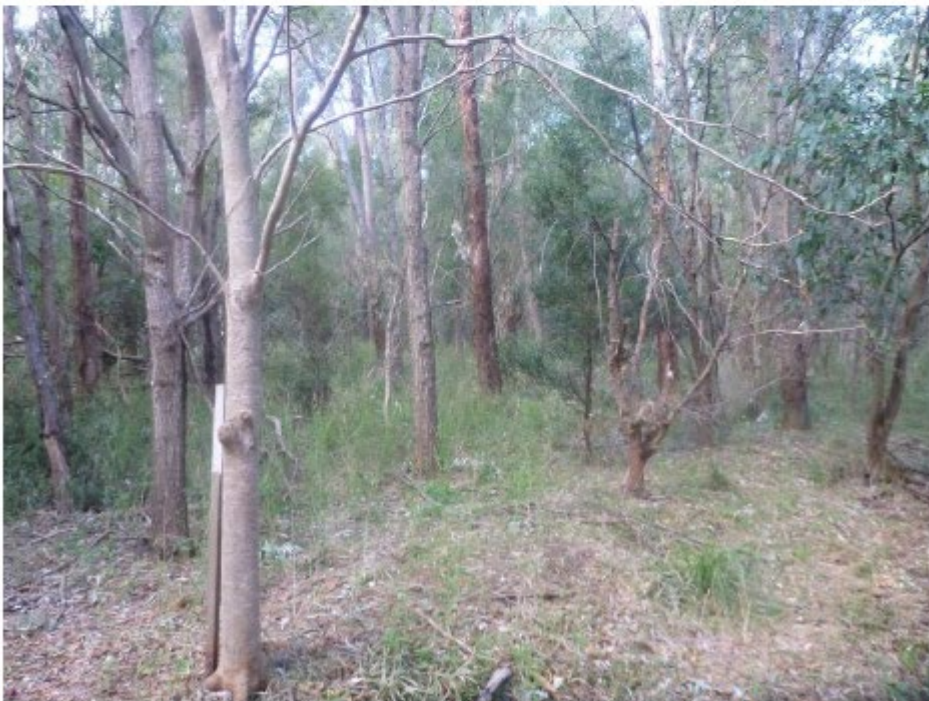
Figure 36 Photomontage of vegetation condition at Zone 3a

Photo Point	3A		
Commencement of works date	September 2020		
Completion of works date	August 2021		
Vegetation Condition		Percentage Cover prior to works	Percentage Cover post works
Upper Stratum (emergent canopy)	The upper stratum surrounding this photo point is dominated by a tall canopy of revegetation <i>Melaleuca armillaris</i> <i>Eucalyptus saligna</i> <i>Acacia maidenii</i>	100% native cover	100% native cover
Mid Stratum (sub canopy)	The mid stratum surrounding this photo point is dominated by <i>Hakea salicifolia</i> <i>Dodonea viscosa</i> <i>Glochidion ferdinandi</i>	100% native cover 0% weed cover	100% native cover 0% weed cover
Shrub layer	The shrub layer surrounding this photo point is dominated by <i>Lantana camara</i> * <i>Solanum mauritianum</i> *	100% native cover 0% weed cover	0% native cover 0% weed cover
Ground Layer	The ground layer surrounding this photo point is dominated by native and weed grasses as well as a range of annual weeds and woody weed seedlings such as <i>Sida rhombifolia</i> * <i>Bidens pilosa</i> * <i>Sigesbeckia orientalis</i>	40% native cover 60% weed cover	80% native cover 20% weed cover

3A Photo point prior to commencement of works

The same view after primary and secondary weed control works, September 2021

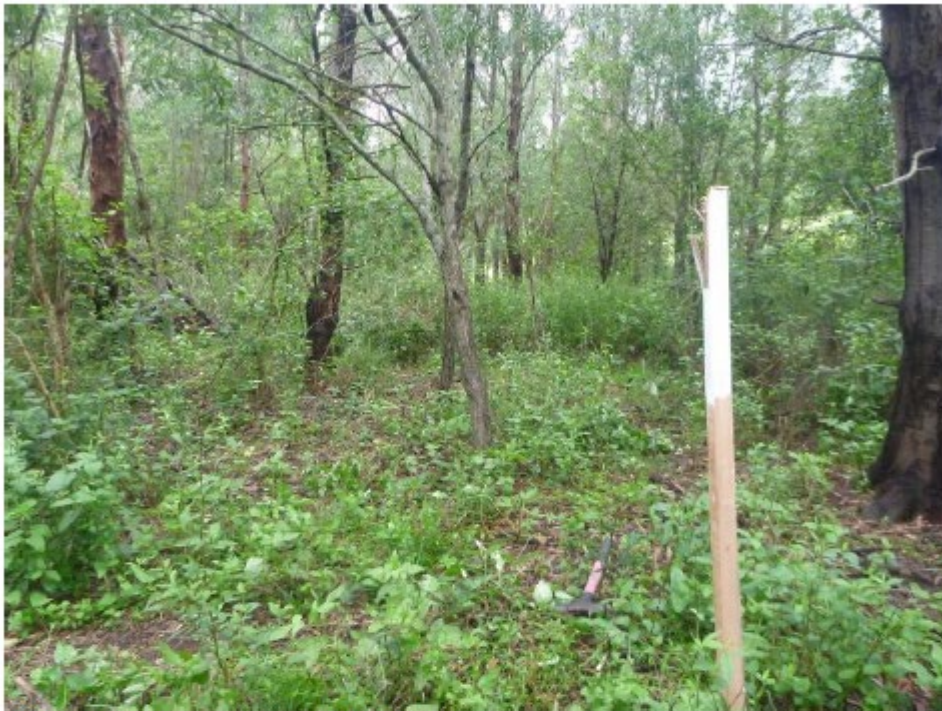
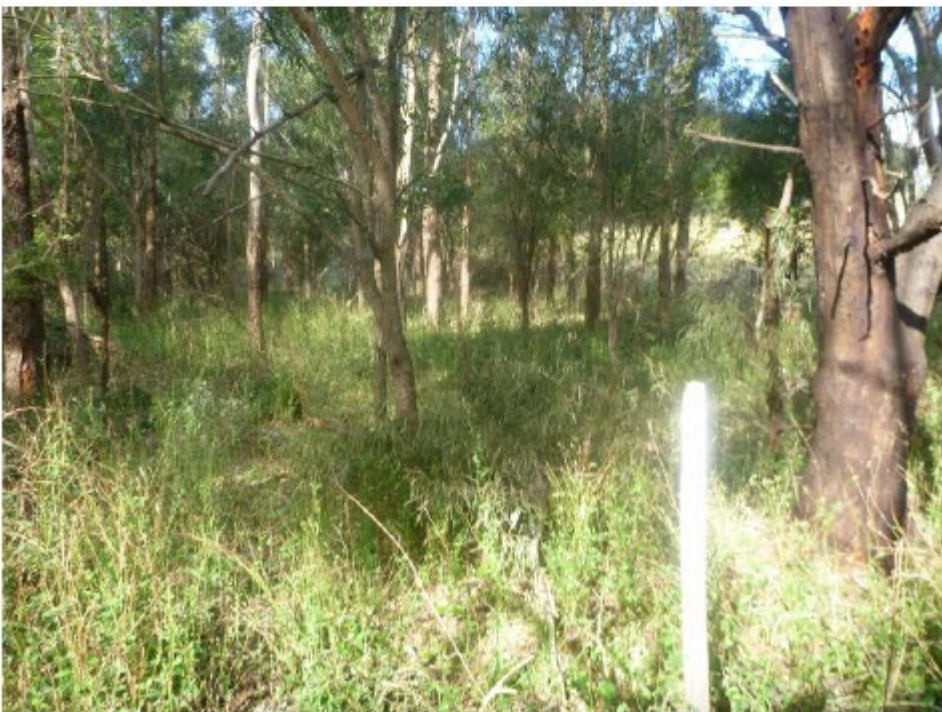
Figure 37 Photomontage of vegetation condition at Zone 3b

Photo Point	3B		
Commencement of works date	September 2020		
Completion of works date	August 2021		
Vegetation Condition		Percentage Cover prior to works	Percentage Cover post works
Upper Stratum (emergent canopy)	The upper stratum surrounding this photo point is dominated by a tall canopy of revegetation <i>Melaleuca armillaris</i> <i>Eucalyptus saligna</i> <i>Acacia maidenii</i>	100% native cover	100% native cover
Mid Stratum (sub canopy)	The mid stratum surrounding this photo point is dominated by <i>Hakea salicifolia</i> <i>Dodonea viscosa</i> <i>Glochidion ferdinandi</i>	100% native cover 0% weed cover	100% native cover 0% weed cover
Shrub layer	The shrub layer surrounding this photo point is dominated by <i>Lantana camara</i> * <i>Solanum mauritianum</i> *	100% native cover 0% weed cover	0% native cover 0% weed cover
Ground Layer	The ground layer surrounding this photo point is dominated by native and weed grasses as well as a range of annual weeds and woody weed seedlings such as <i>Sida rhombifolia</i> * <i>Bidens pilosa</i> * <i>Sigesbeckia orientalis</i>	40% native cover 60% weed cover	80% native cover 20% weed cover

3B Photo point prior to commencement of works

The same view after primary and secondary weed control works, September 2021

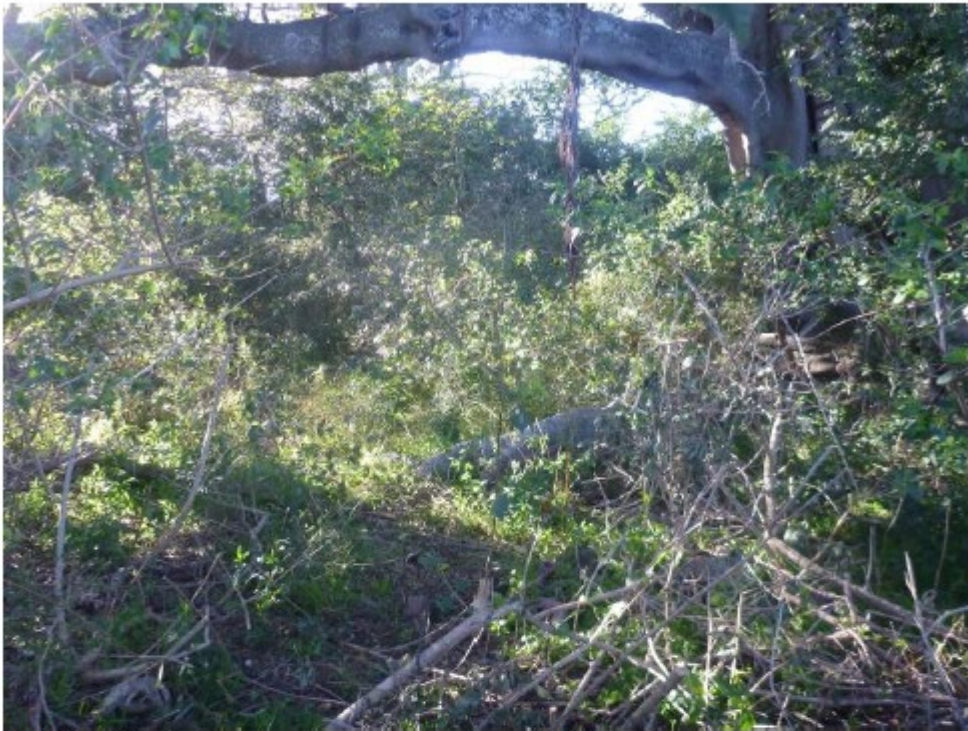
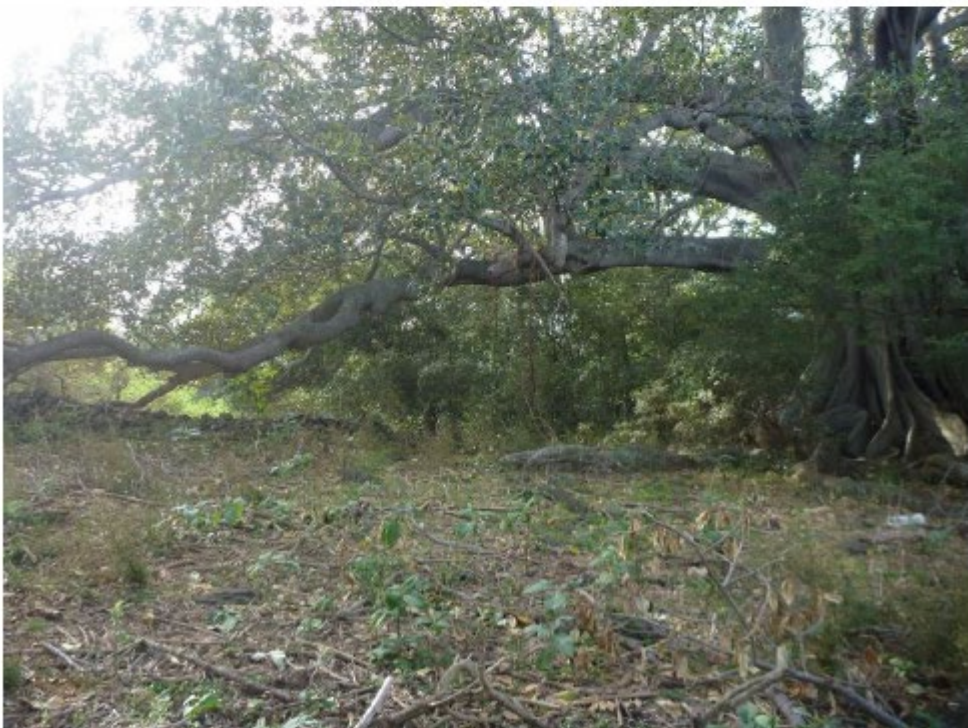
Figure 38 Photomontage of vegetation condition at Zone 3d

Photo Point	3D		
Commencement of works date	September 2020		
Completion of works date	August 2021		
Vegetation Condition		Percentage Cover prior to works	Percentage Cover post works
Upper Stratum (emergent canopy)	The upper stratum surrounding this photo point is dominated by a tall canopy of <i>Ficus macrophylla</i>	100% native cover	100% native cover
Mid Stratum (sub canopy)	The mid stratum surrounding this photo point is dominated by <i>Elaeodendron australe</i> <i>Clerodendrum tomentosum</i> <i>Maclura cochinchinensis</i>	100% native cover 20% weed cover	100% native cover 0% weed cover
Shrub layer	The shrub layer surrounding this photo point is dominated by <i>Lantana camara</i> * <i>Cestrum nocturnum</i> <i>Pittosporum multiflorum</i>	30% native cover 70% weed cover	100% native cover 0% weed cover
Ground Layer	The ground layer surrounding this photo point is dominated by native and weed grasses as well as a range of annual weeds and woody weed seedlings such as <i>Oplismenis imbecillis</i> <i>Bidens pilosa</i> * <i>Solanum pseudocapsicum</i> *	40% native cover 60% weed cover	70% native cover 30% weed cover

3D Photo point prior to commencement of works August 2020

3D Photo after primary weed control September 2021

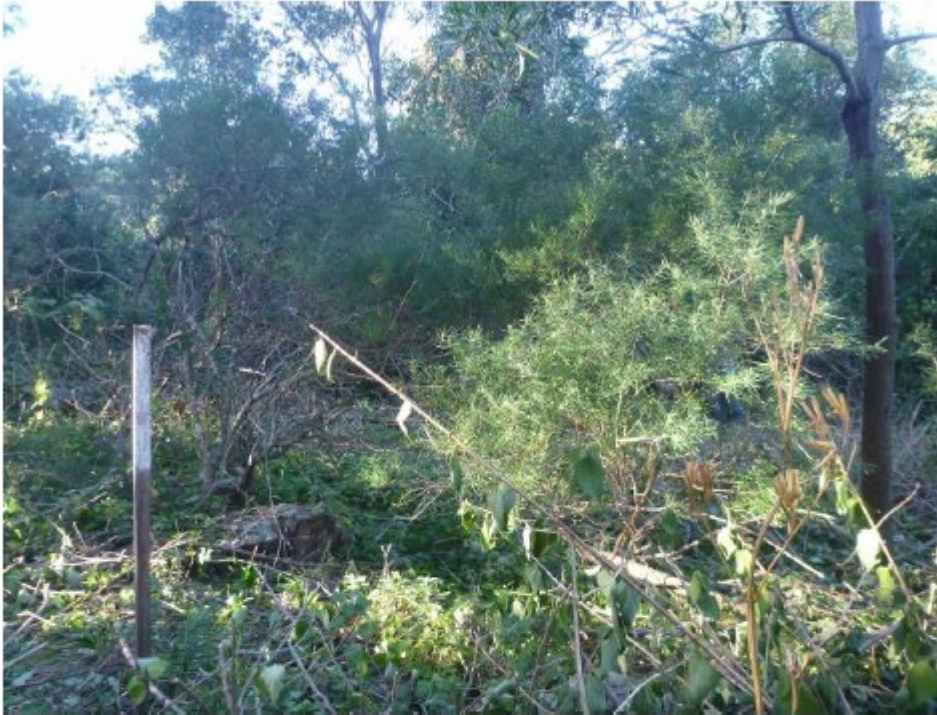
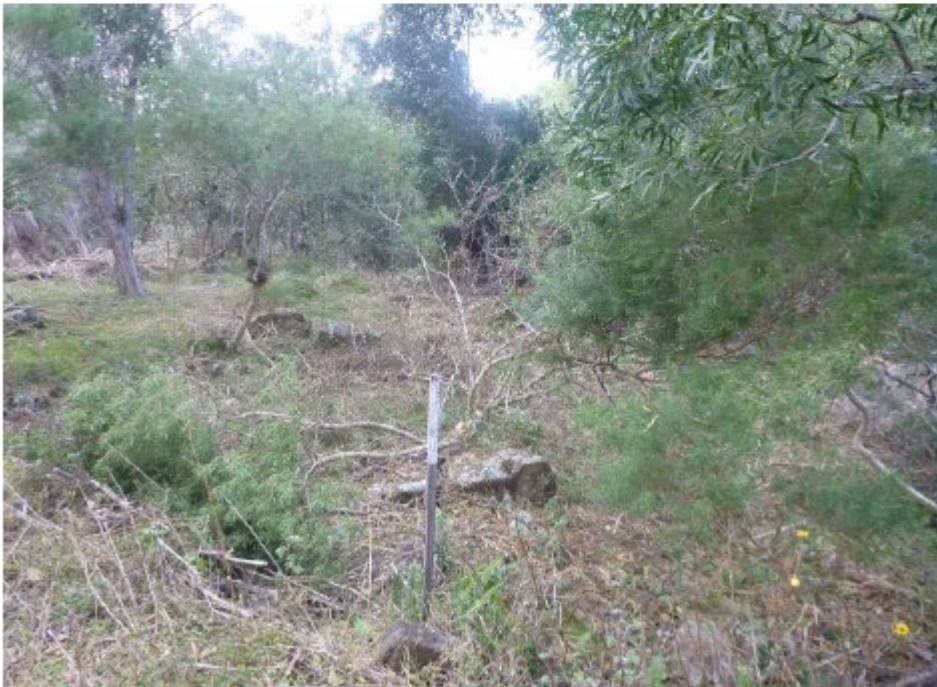
Figure 39 Photomontage of vegetation condition at Zone 3c

Photo Point	3C		
Commencement of works date	September 2020		
Completion of works date	August 2021		
Vegetation Condition		Percentage Cover prior to works	Percentage Cover post works
Upper Stratum (emergent canopy)	The upper stratum surrounding this photo point is dominated by a tall canopy of <i>Melaleuca armillaris</i> <i>Acacia maidenii</i>	100% native cover	100% native cover
Mid Stratum (sub canopy)	The mid stratum surrounding this photo point is dominated by <i>Clerodendrum tomentosum</i> <i>Maclura cochinchinensis</i> <i>Ehretia accuminata</i> <i>Solanum mauritianum</i> *	80% native cover 20% weed cover	100% native cover 0% weed cover
Shrub layer	The shrub layer surrounding this photo point is dominated by <i>Lantana camara</i> * <i>Zieria granulata</i> <i>Croton verreauxii</i>	70% native cover 30% weed cover	100% native cover 0% weed cover
Ground Layer	The ground layer surrounding this photo point is dominated by native and weed grasses as well as a range of annual weeds and woody weed seedlings such as <i>Lantana camara</i> * <i>Bidens pilosa</i> * <i>Pellaea falcata</i>	60% native cover 30% weed cover	80% native cover 20% weed cover

3C Photo Point before primary weed control August 2020
