Boral Cement – Berrima Works Blue Shale Quarry Rehabilitation Management Plan ML 1723

July 2024

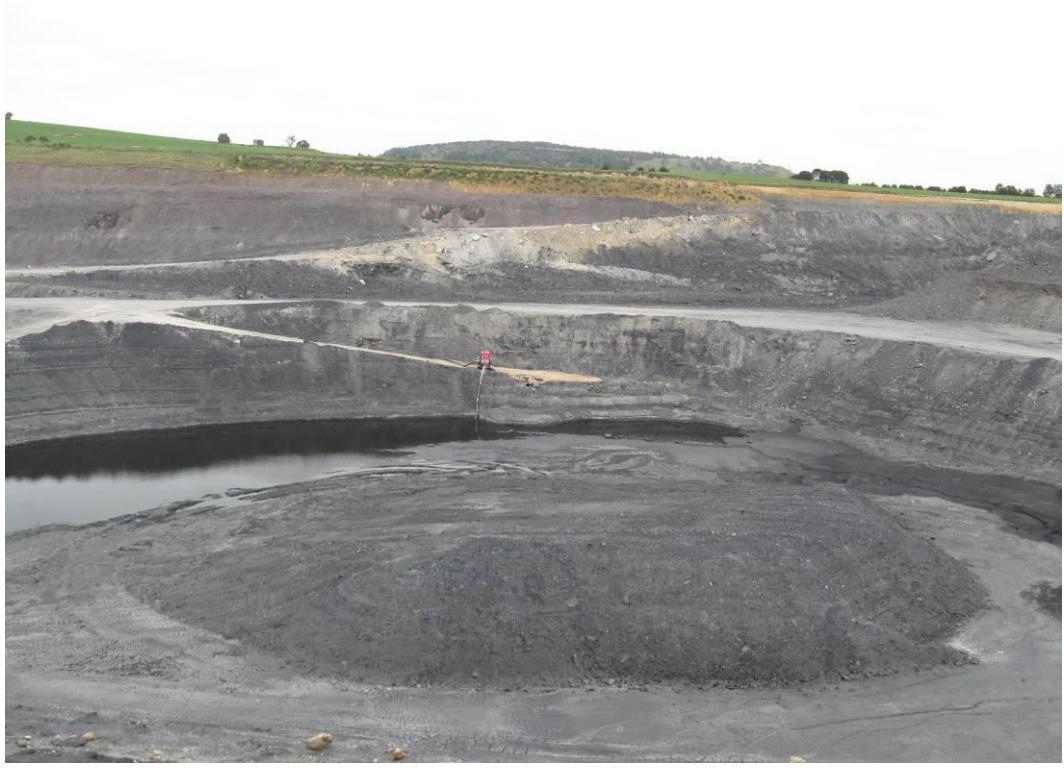
Plate 1 - Current extraction area showing ripped shale pushed up ready for loading

The current extraction area is shown in Plate1.

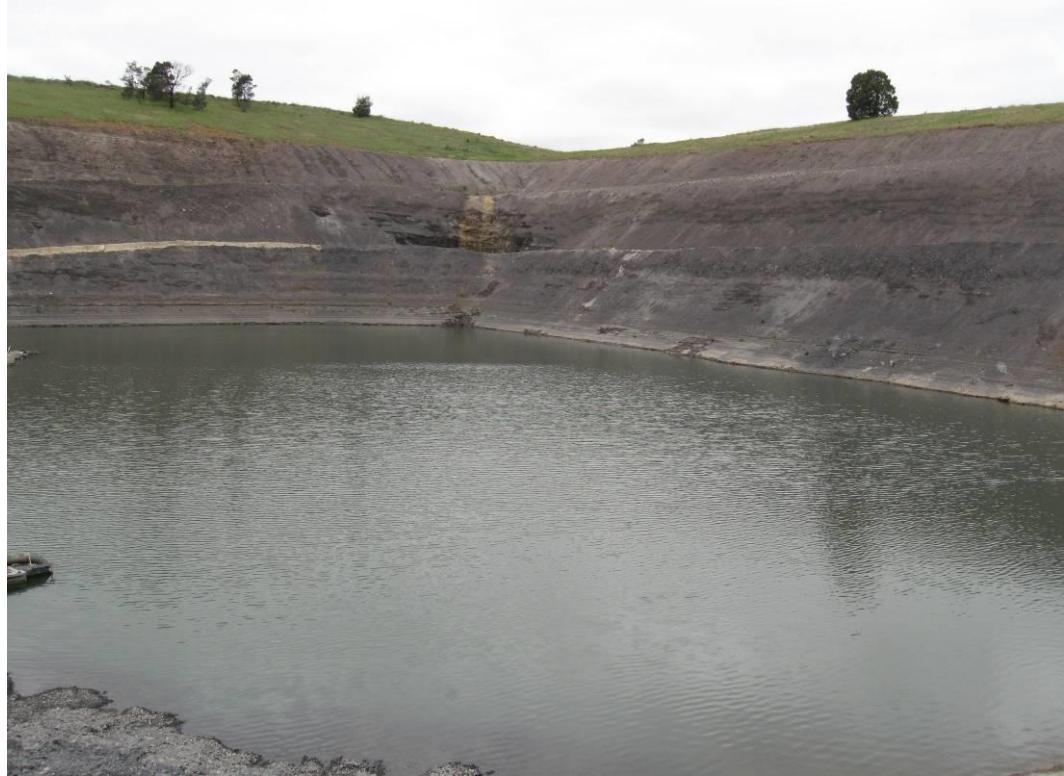
Plate 2 - Water Storage in Eastern Void

During sustained rainfall, excess water is pumped into the eastern void of the shale quarry. This void has been developed as a large water storage as shown on Plate 2. This system has allowed the Works to significantly reduce its dependence on the Wingecarribee River and only use the river as a backup during periods of extended dry weather when the dams are low. Water is pumped back to the Cement Works via an overland pipeline as shown on Plate 3.

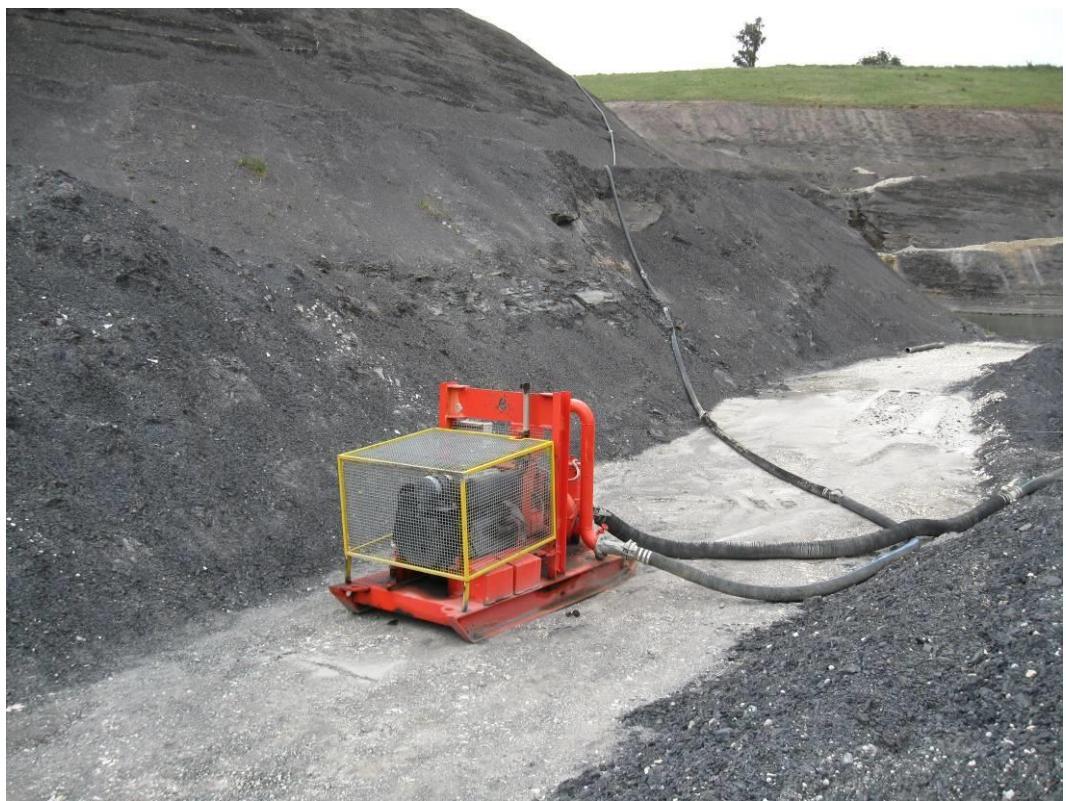
Plate 3 - Pump to deliver water back to the Cement Works

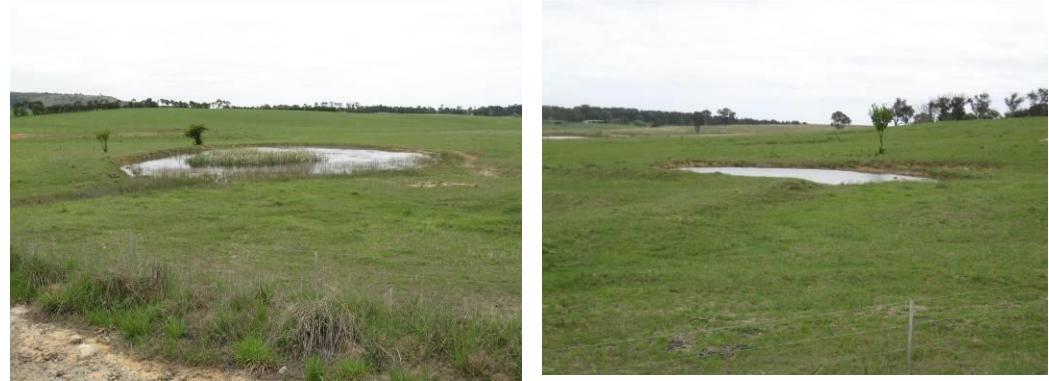
Plate 4 - Clean Water Catch Dams to west of current extraction area

There are two dams which are located on drainage lines that enter the quarry area that were established as construction sediment control dams when the quarry commenced. These dams will eventually be mined through and will be replaced by additional clean water diversion channels. The two dams are shown on Plate 4.

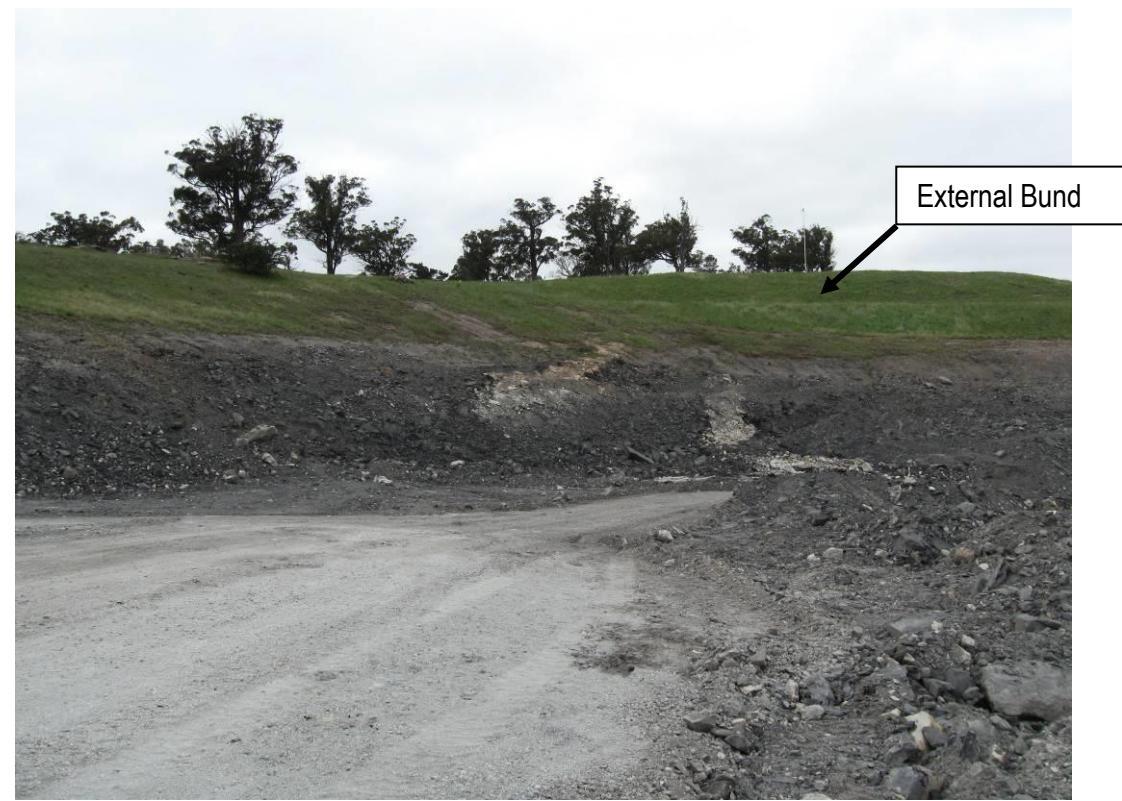
Plate 5 – External Bund Constructed from Overburden

At the commencement of this RMP Period, rehabilitation activities have occurred on the external areas around the quarry void. The main area is Domain A4 which includes the original overburden emplacement which has been shaped as a bund around the eastern quarry extraction area as shown on Plate 5.

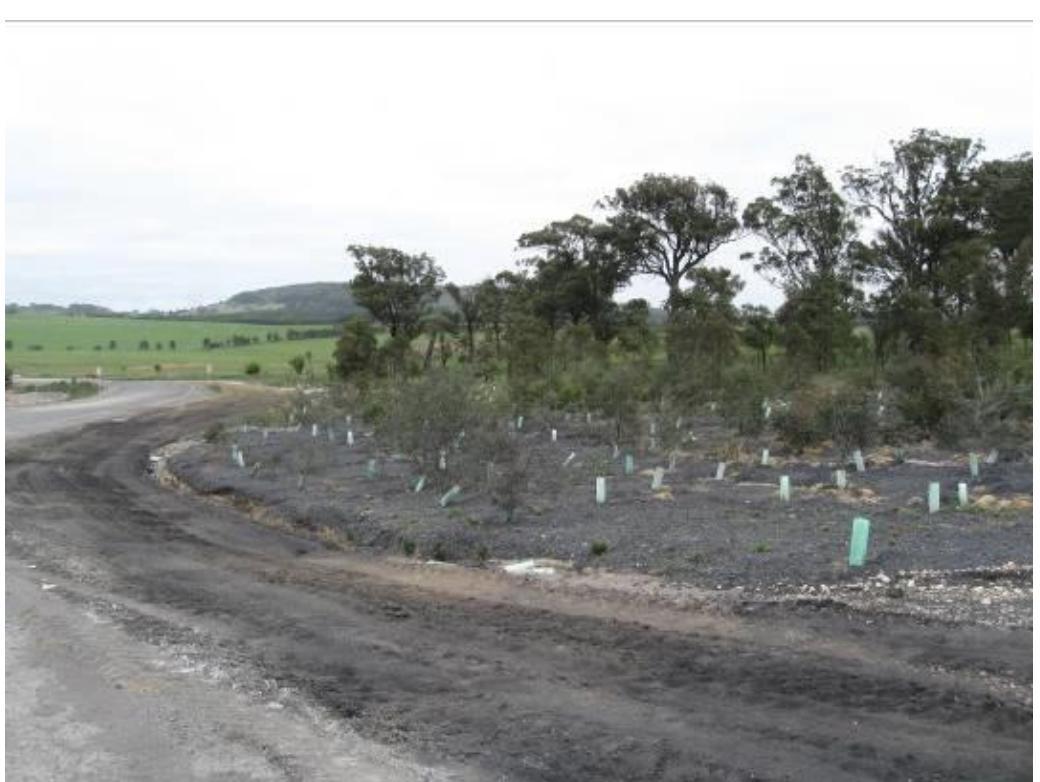
Plate 6 - Tree Planting Directly into Ashfield Shale

Domain A4 also includes areas of tree planting to the north of the quarry extraction area. The tree planting was part of an overall program at the cement works to improve dust control, scenic quality and habitat improvement. The planting involved areas that had previously been rehabilitated to improved pasture as well as recent disturbed areas adjacent to haul roads, as shown on Plate 6.

Plate 6 was taken adjacent to the main access road on the northern side of the quarry. This shows an area of direct tree planting into Ashfield Shale. These trees are growing well, arguably better than areas that were previously rehabilitated using improved pasture.

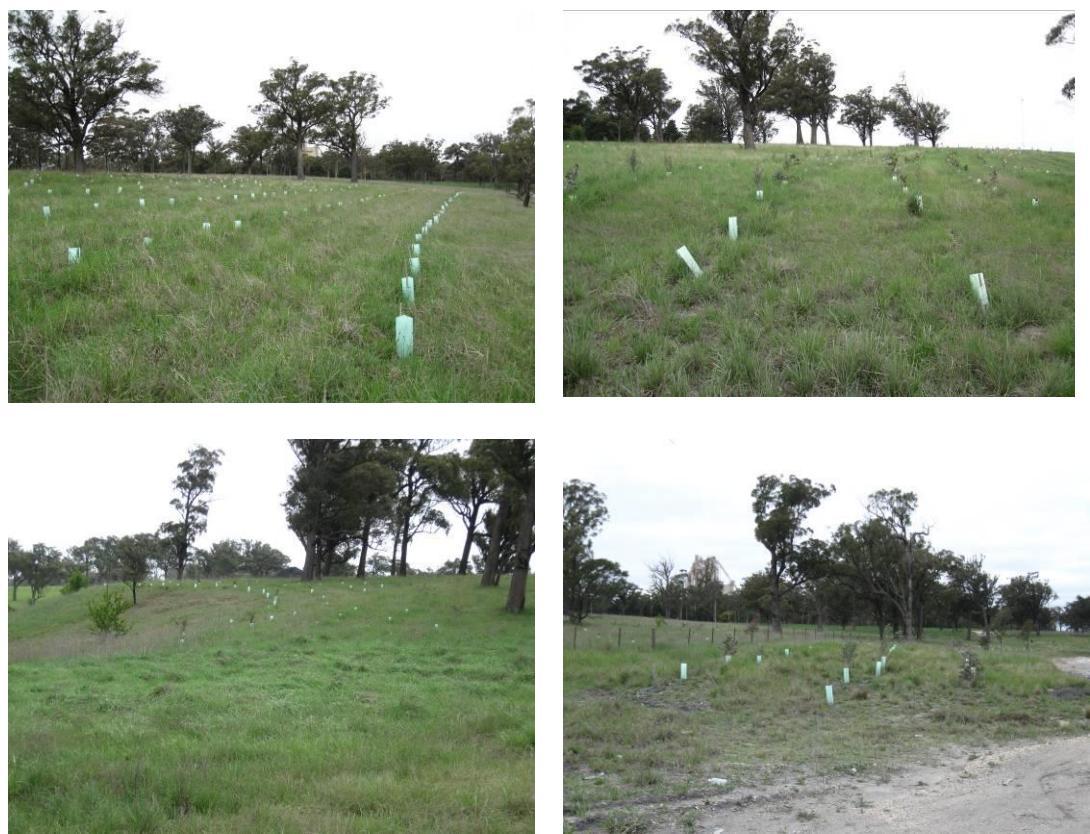
Plate 7 - Domain A4 Tree Planting

Plate 7 below show examples of tree planting around the northern section of the quarry.

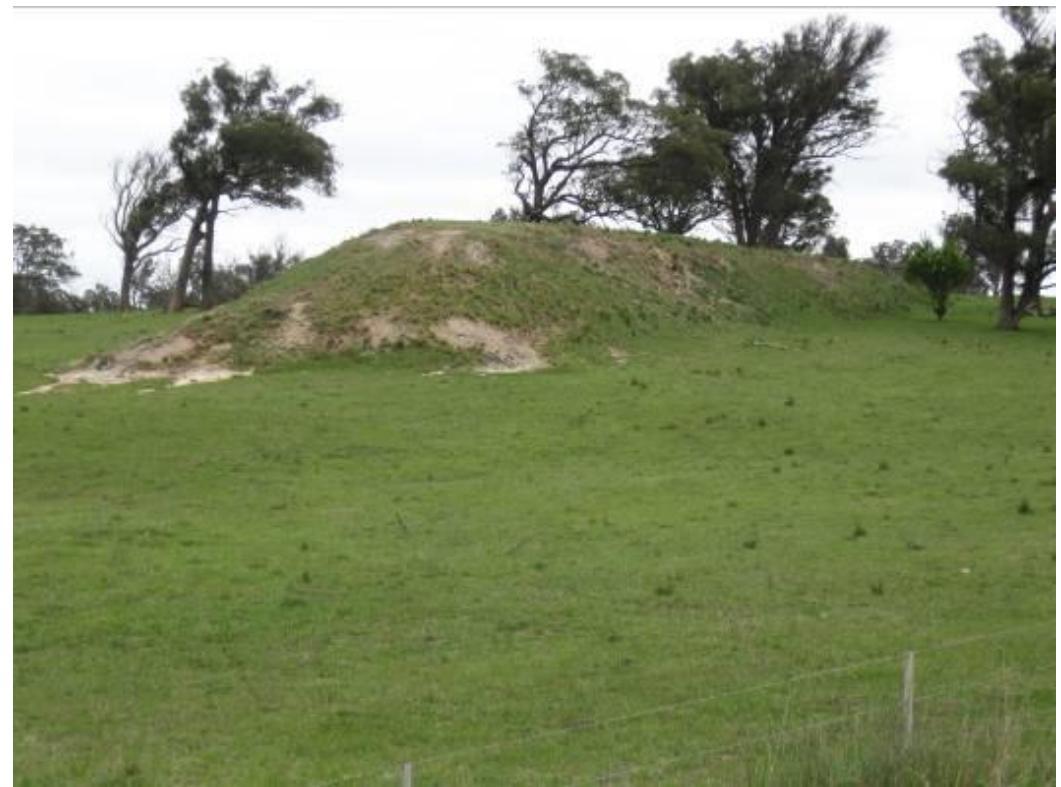
Plate 8 - Transitional Rehabilitation

Plate 8 below shows an area of transitional rehabilitation consisting of excess topsoil and subsoil generated during the original quarry development. The material has been emplaced in a long but relatively shallow emplacement located just outside the next extension of the quarry footprint. This material will not be required for several years but eventually will be used in the rehabilitation of finished berms.

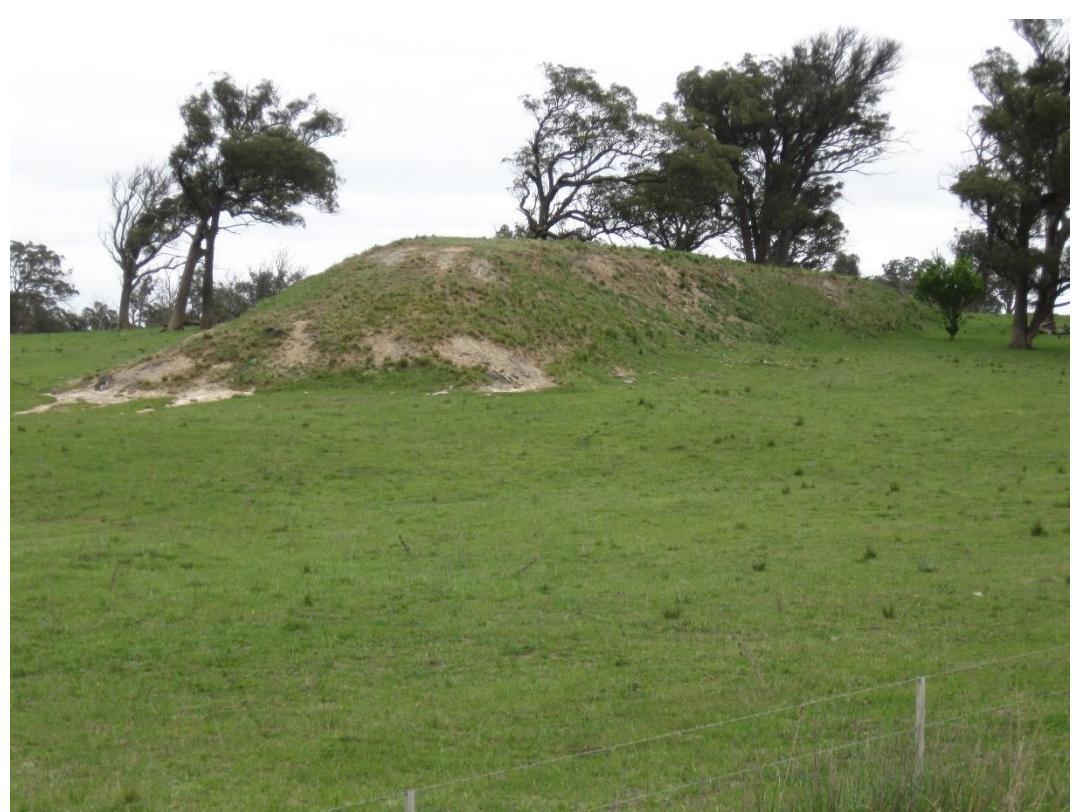
Plate 9 – Existing Topsoil Stockpile

The current topsoil stockpile, shown on Plate 9, has been in place for over 20 years and shows signs of deterioration. This stockpile area lies within the footprint of the future quarry footprint and will ultimately have to be relocated.
