# **Boral Cement – Berrima Works Blue Shale Quarry Rehabilitation Management Plan ML 1723**

**July 2022**

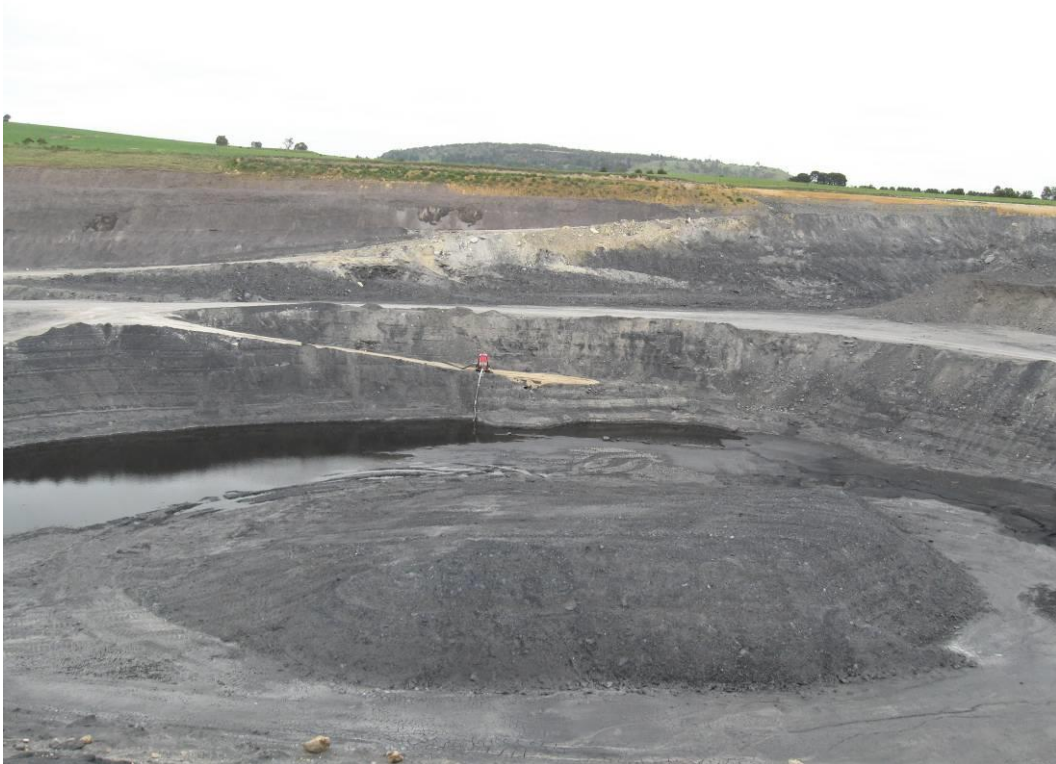
**Plate 1 - Current extraction area showing ripped shale pushed up ready for loading**

The current extraction area is shown in Plate 1.

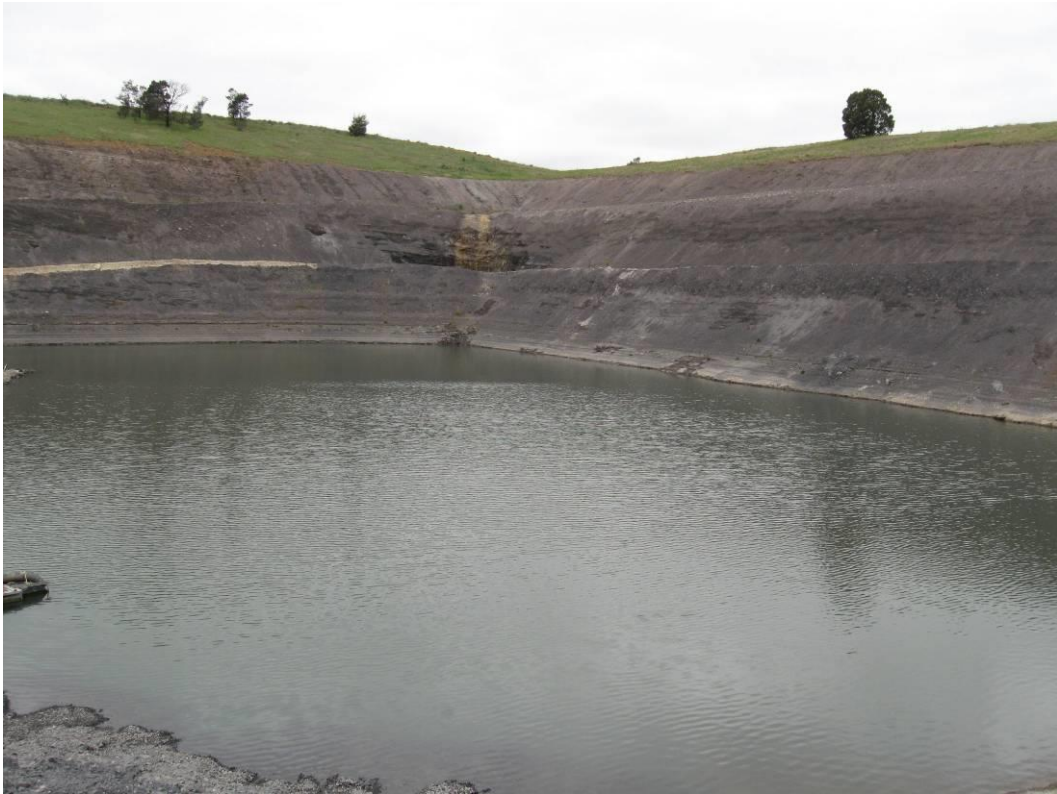
**Plate 2 - Water Storage in Eastern Void**

During sustained rainfall, excess water is pumped into the eastern void of the shale quarry. This void has been developed as a large water storage as shown on Plate 2. This system has allowed the Works to significantly reduce its dependence on the Wingecarribee River and only use the river as a backup during periods of extended dry weather when the dams are low. Water is pumped back to the Cement Works via an overland pipeline as shown on Plate 3.

Some external surface water also drains into the void as well as direct rainfall. This water is captured and pumped into the eastern water storage where it is kept until required by the Cement Works.

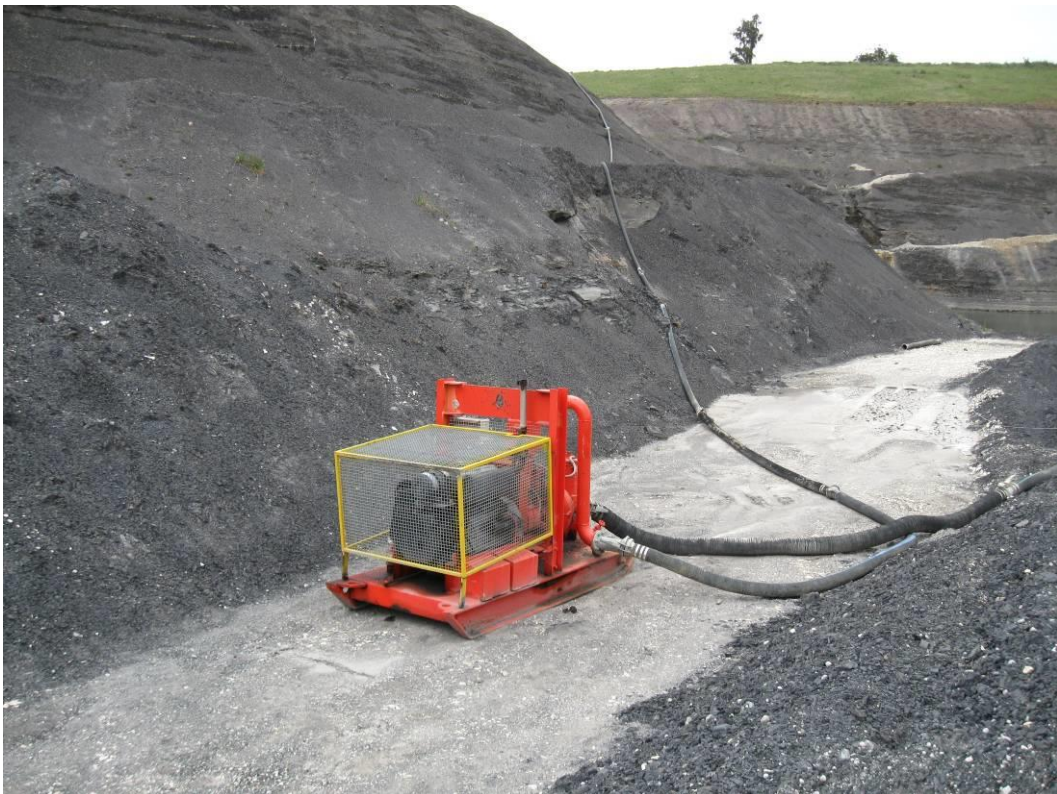
**Plate 3 - Pump to deliver water back to the Cement Works**

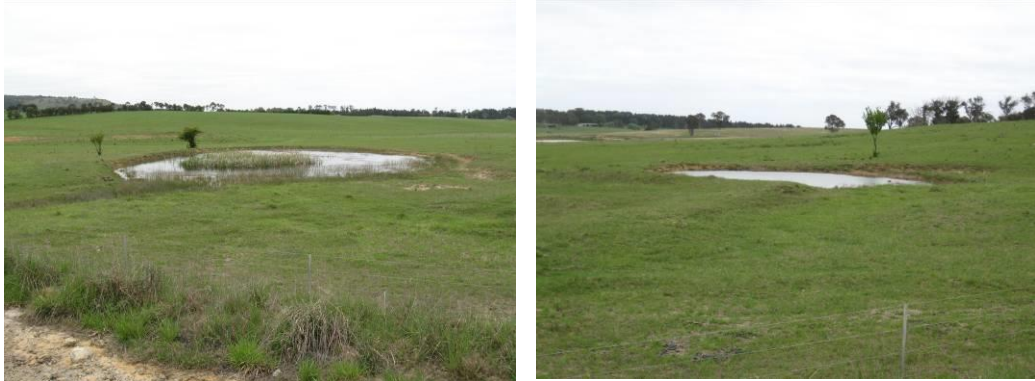
**Plate 4 - Clean Water Catch Dams to west of current extraction area**

There are two dams which are located on drainage lines that enter the quarry area that were established as construction sediment control dams when the quarry commenced.

These dams will eventually be mined through and will be replaced by additional clean water diversion channels. The two dams are shown on Plate 4.

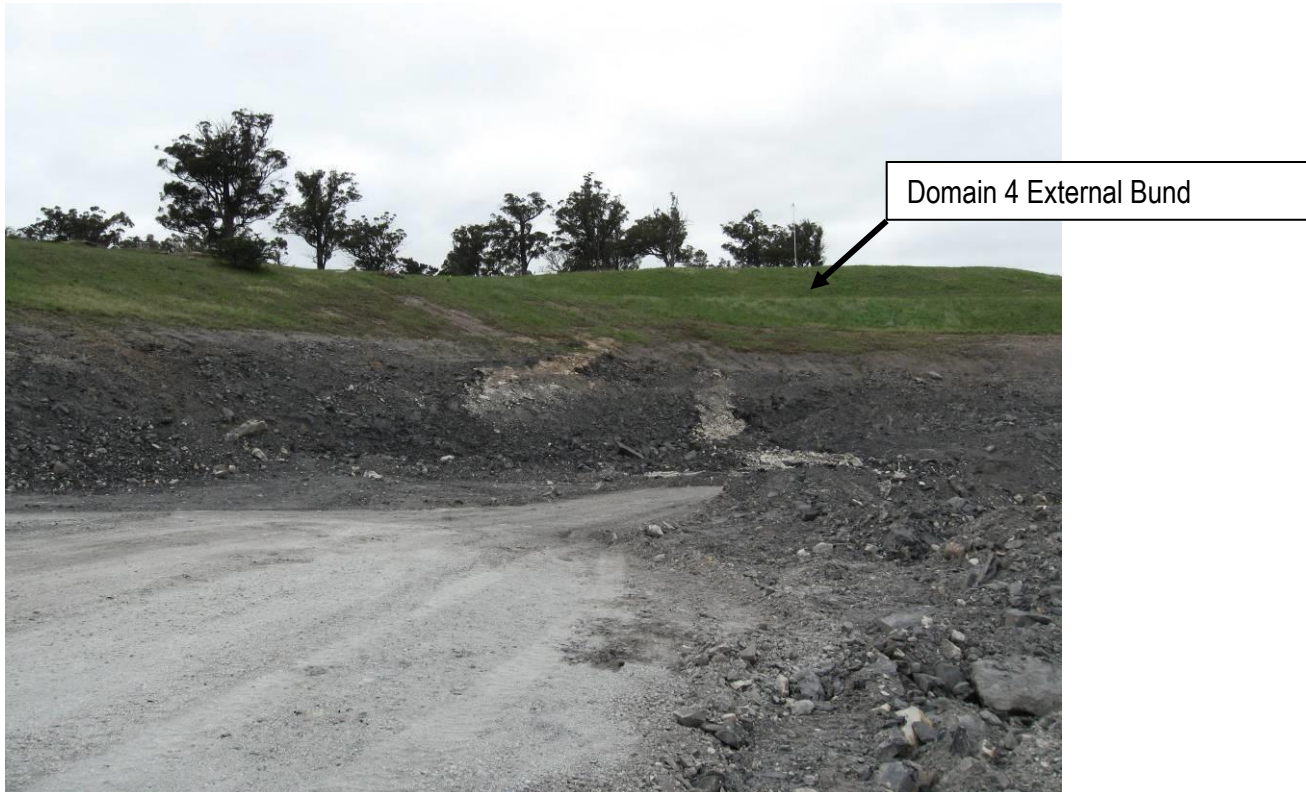
**Plate 5 - View of Domain 4 in Background**

At the commencement of this RMP Period, rehabilitation activities have occurred on the external areas around the quarry void. The main area is Domain 4 which includes the original overburden emplacement which has been shaped as a bund around the eastern quarry extraction area as shown on Plate 5.

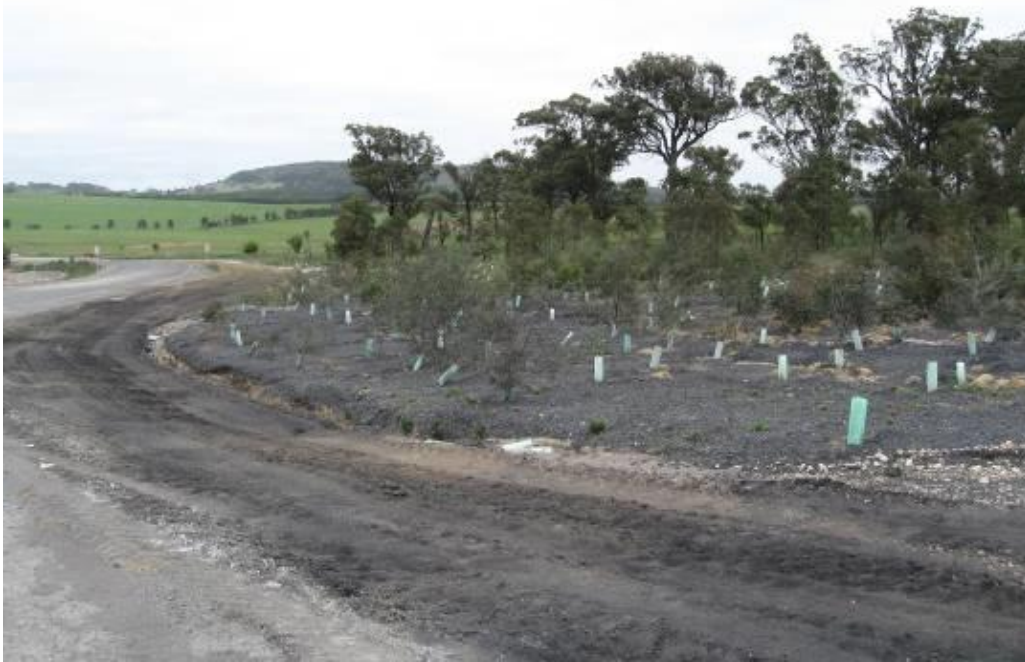
Plate 6 was taken adjacent to the main access road on the northern side of the quarry. This shows an area of direct tree planting into Ashfield Shale. These trees are growing well, arguably better than areas that were previously rehabilitated using improved pasture.

**Plate 6 - Tree Planting Directly into Ashfield Shale**

Domain 4 also includes areas of tree planting to the north of the quarry extraction area. The tree planting was part of an overall program at the cement works to improve dust control, scenic quality and habitat improvement. The planting involved areas that had previously been rehabilitated to improved pasture as well as recent disturbed areas adjacent to haul roads, as shown on Plate 6.

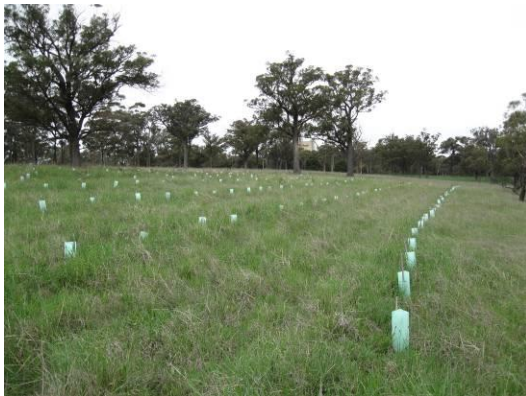
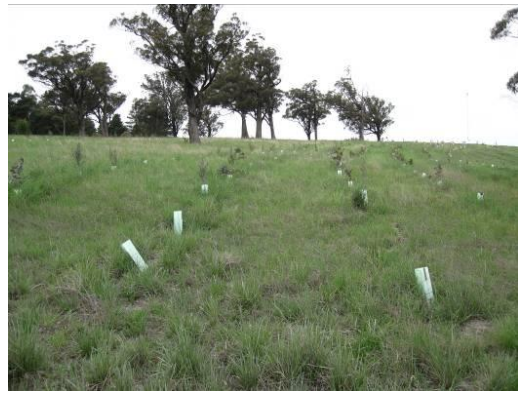
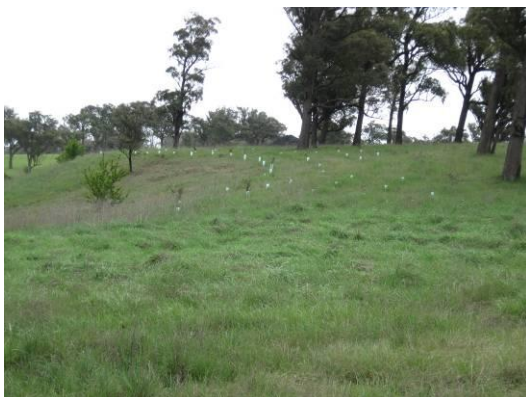
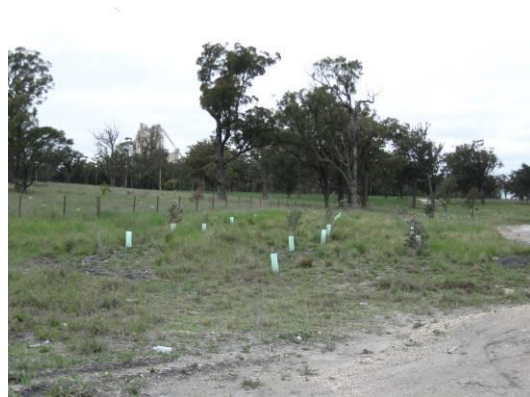
**Plate 7 - Domain 4 Tree Planting**

Plate 7 below show examples of tree planting around the northern section of the quarry.

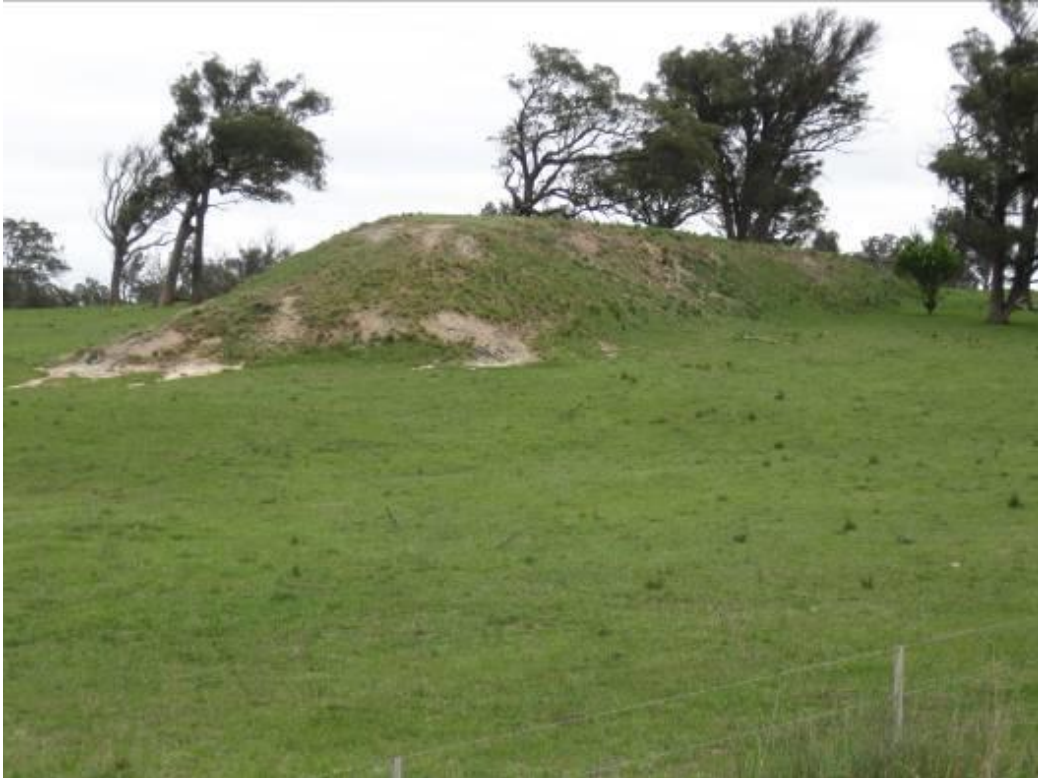
Plate 8 below shows an area of transitional rehabilitation consisting of excess topsoil and subsoil generated during the original quarry development. The material has been emplaced in a long but relatively shallow emplacement located just outside the next extension of the quarry footprint. This material will not be required for several years but eventually will be used in the rehabilitation of finished berms.

**Plate 8 - Transitional Rehabilitation**

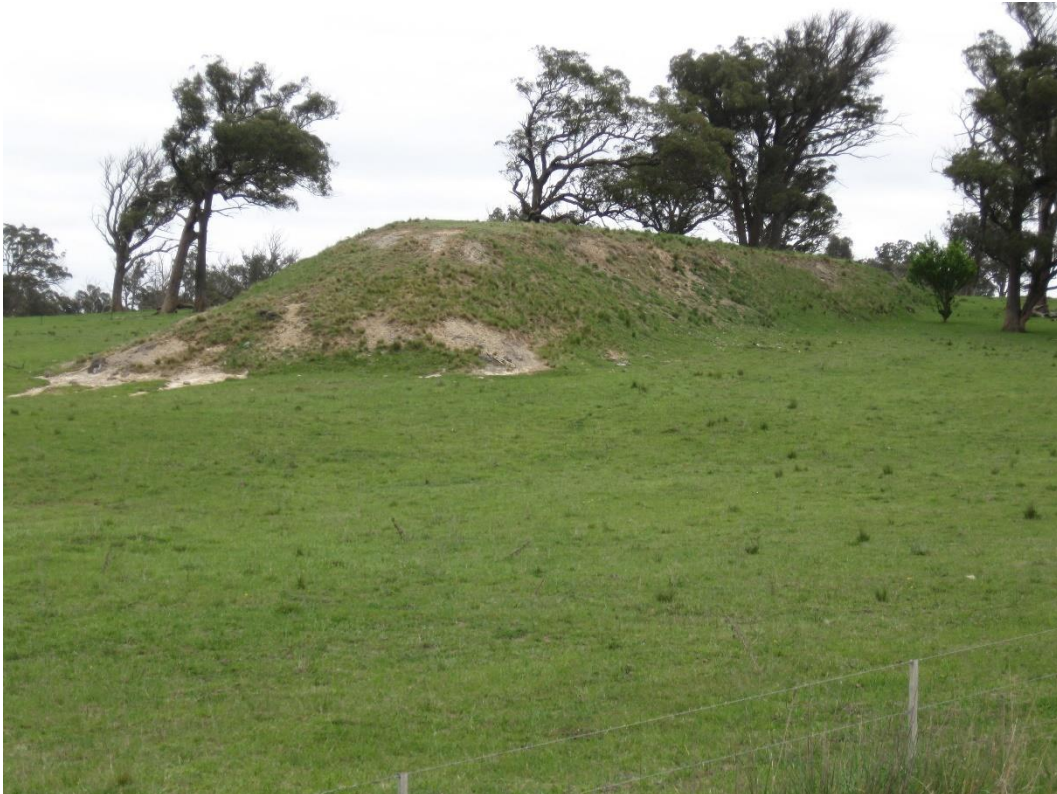
The current topsoil stockpile, shown on Plate 1, has been in place for over 20 years and shows signs of deterioration. This stockpile area lies within the footprint of the future quarry footprint and will ultimately have to be relocated.

**Plate 1 – Existing Topsoil Stockpile**
